# Fixing A Broken Trout Stream

Donegal Creek Restoration Project  
Written by Mark A. Metzler

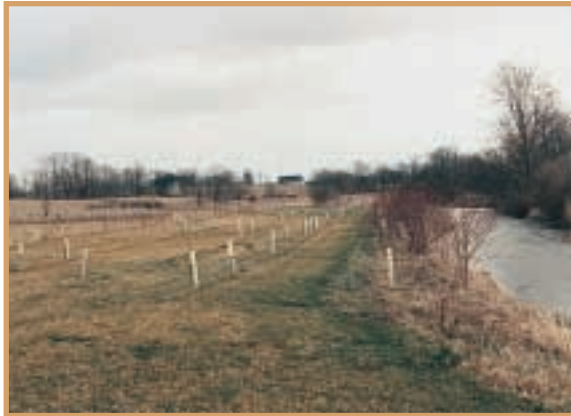
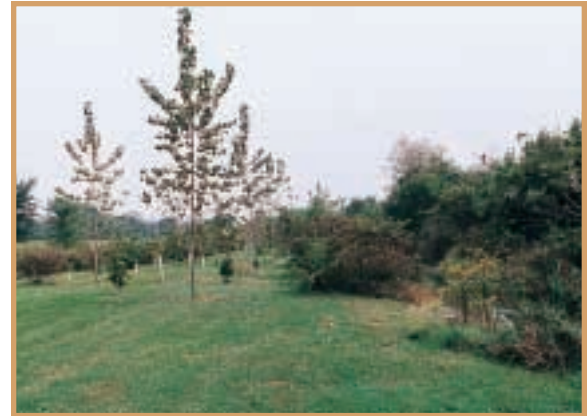
*Before & After*  
Forrest buffer  
planting on  
Donegal's west  
branch. The  
buffer is 50' wide  
and includes 2  
rows of shrubs.

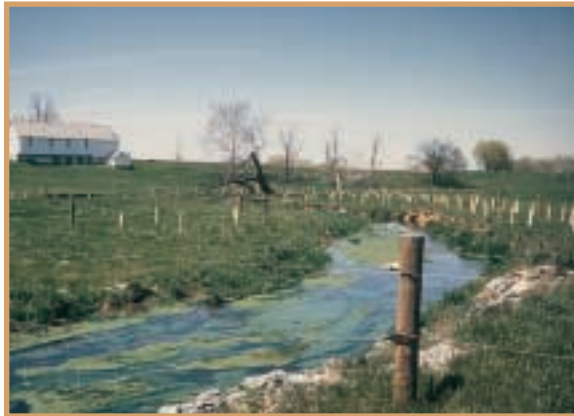
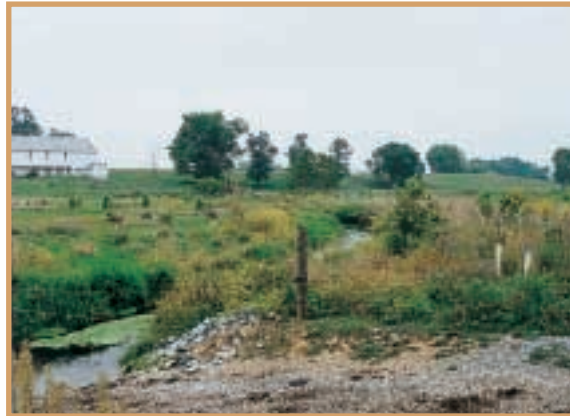
*Before & After*  
Forrest buffer  
planting on  
Donegal's east  
branch. The  
buffer in some  
locations exceeds  
100' in width.  
Notice the use  
of tree protector  
tubes.

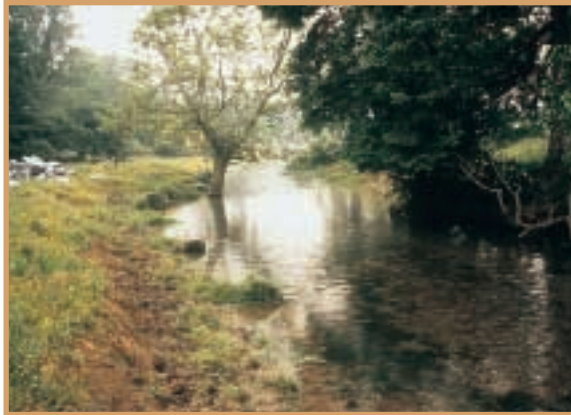
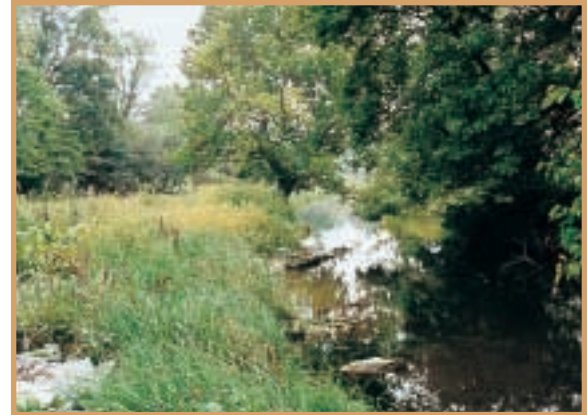
*Before & After*  
The installation of 2 rock deflectors and streambank fencing repaired this badly eroded streambank on Donegal's east branch. This all took place within one year.

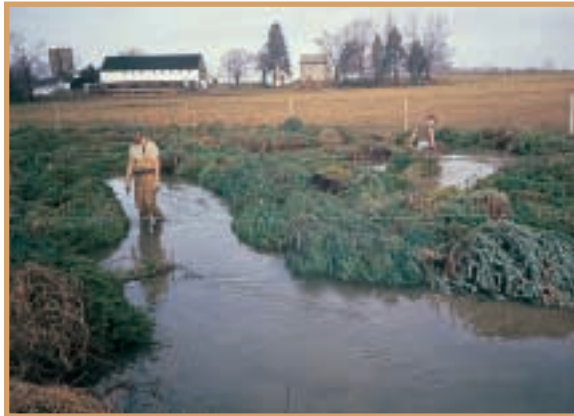
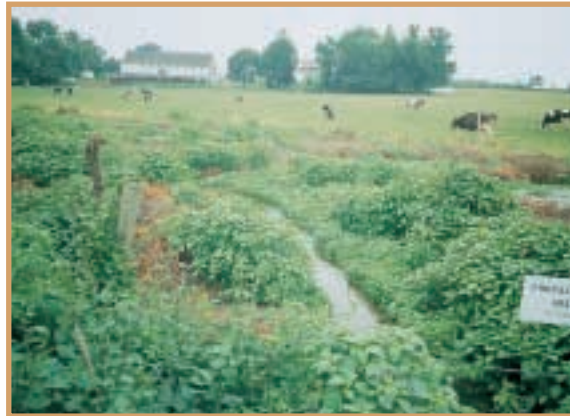
*Before & After*  
Used Christmas trees were utilized to build this "porcupine deflector." Notice the extremely wide and shallow stream channel in the first photo compared to the second photo.

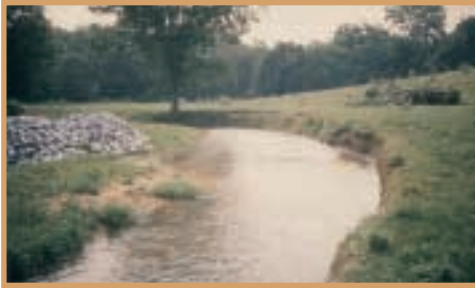
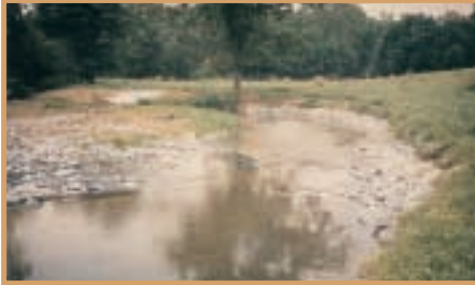
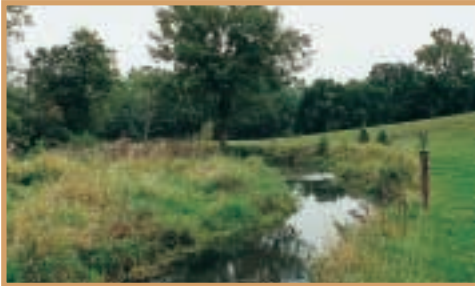
This photo series shows, from top to bottom, stream improvement work that took place in the Donegal's main stem. Improvements consisted of installing 2 log deflectors, 1 inverted "V" dam, 1 cattle crossing, 2 fence stiles, streambank fencing and a forest buffer planting.

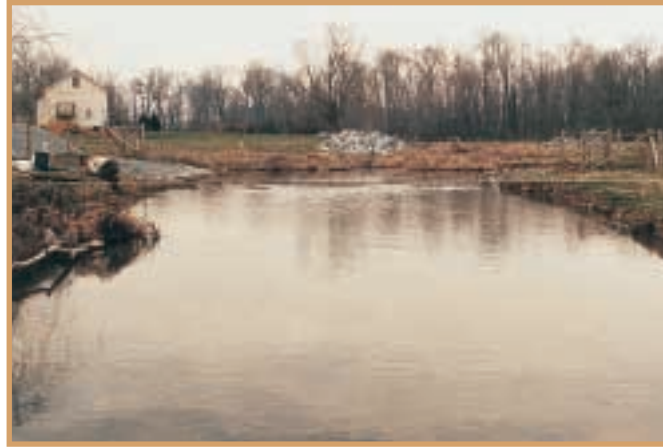
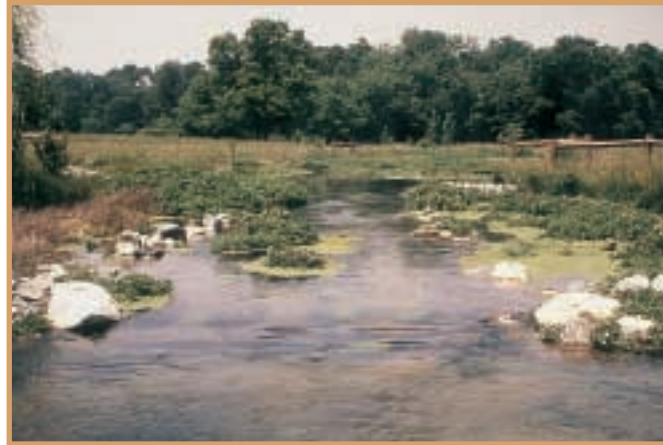
This is a view of Monitoring Station #2 on the Donegal's west branch. In 1997, there were no trout in this pasture. After improvements such as re-fencing plus the installation of deflectors and log "bumps", trout could again be seen sipping blue-winged olive mayflies from the surface in 1998.

Monitoring station #2 is located in a pasture setting approximately 500 feet downstream from station #1. Prior to restoration activities, station #2 was severely impacted by a free ranging dairy herd. The stream channel was extremely wide and shallow. Little in-stream cover and plant life existed. Since the introduction of stream-bank fencing and structural habitat, station #2 is coming alive. Prior to improvements, bloodworms (*Chironomus* species) dominated the invertebrate population, but now sowbugs and scuds are becoming the more dominating species as the muddy substrate is replaced with clean gravel and rock outcroppings. Various dace and mottled sculpin are the dominant fish species.
