COLDWATER CONSERVATION PLAN

Furnace Run and Segloch Run 2004

Rettew Associates, Inc.

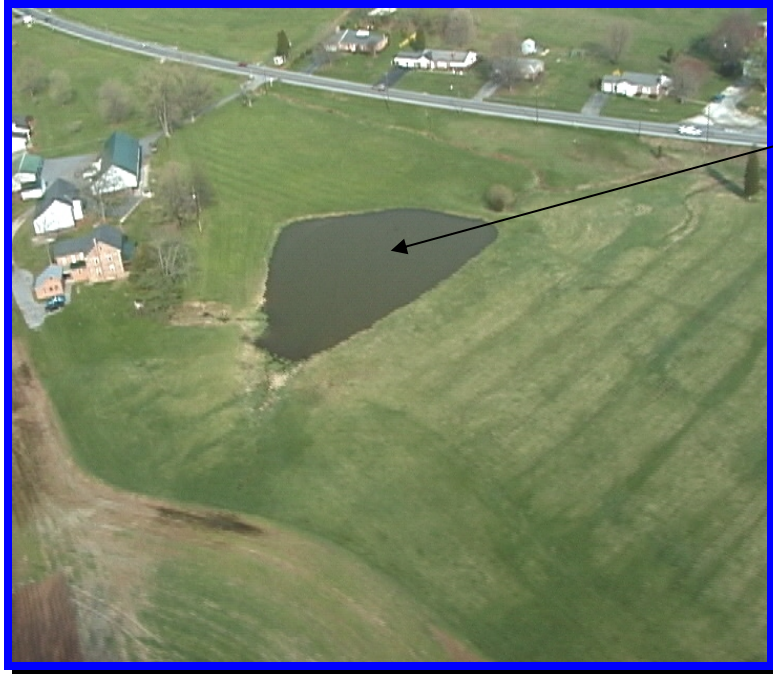
Photos #1 and #2

Improvements in the way of installing a bottom discharge to draw the cold bottom water from the pond would greatly aid in maintaining Furnace Run as a coldwater fishery as would the planting of a forest riparian buffer around the pond and the stream channel.

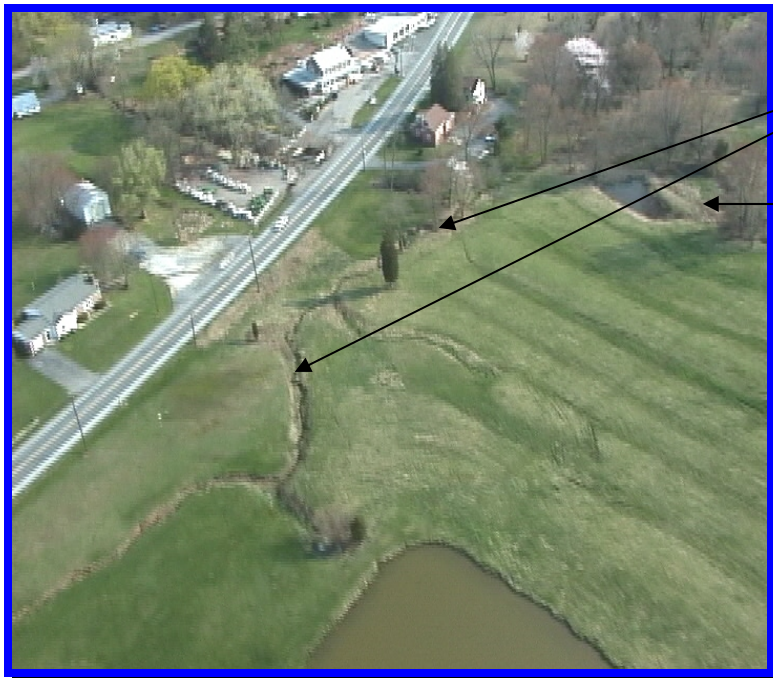
The second, smaller pond is fairly well shaded and less of a priority in regards to installing a forest buffer.

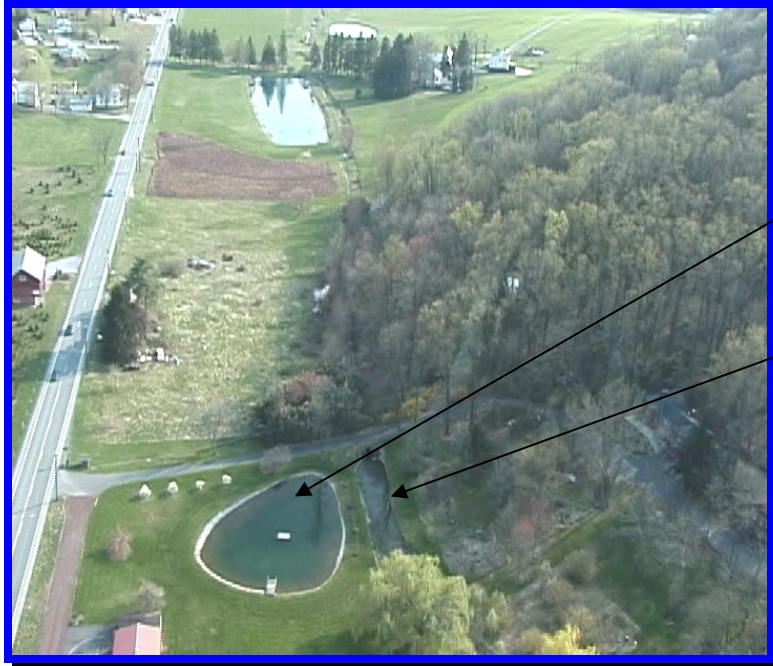
Photos #5 and #6

Furnace Run can be seen to the right of the pond. A lawn condition is maintained right up to the top of the stream bank in this backyard setting.

It is suspected the pond is chemically treated with possibly “Aqua-shade” given its unnaturally blue color as viewed from the air. The “Aqua-shade” product is not necessary harmful to Furnace Run, but other chemicals such as copper sulfate commonly used to control algae blooms could be damaging to the aquatic community in Furnace Run because of its possible disruption to the food chain beginning with in-stream plant materials (including necessary algae).

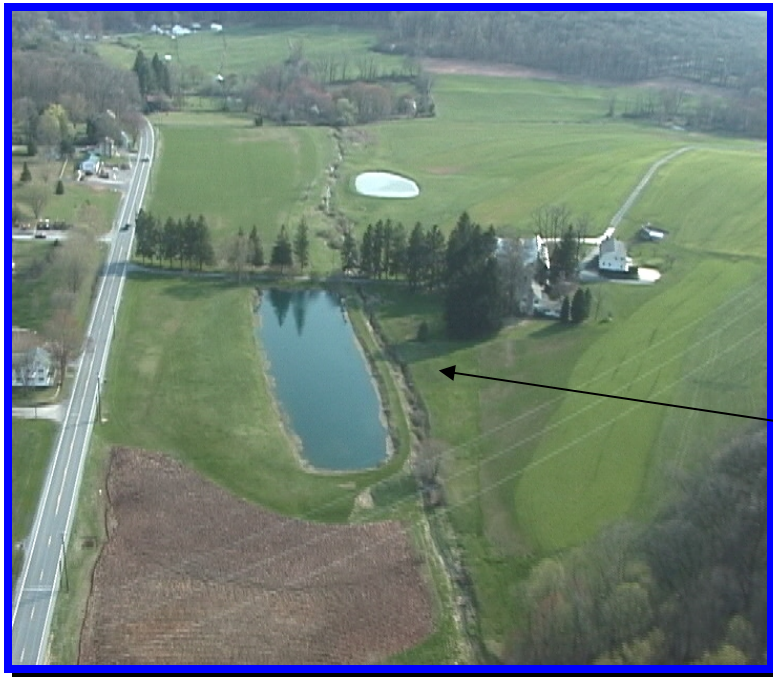
Tract #11 and its two farm ponds. As was the case with the ponds on Tract #1, these ponds and stream channel could be improved with forest buffer plantings and bottom discharges in the ponds.

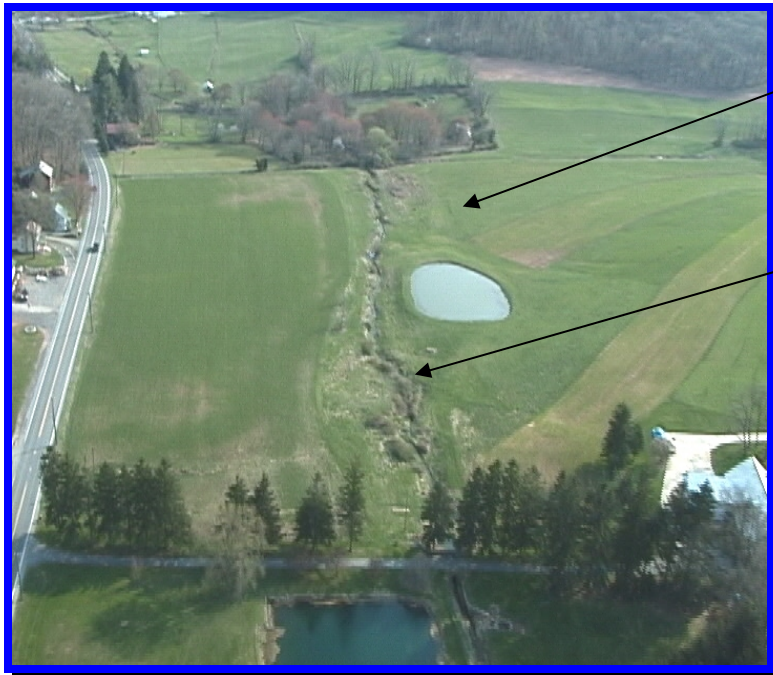
Photo #8 is an aerial view looking at the second, smaller pond on Tract #11.

A well planned and planted forest buffer would be a beneficial "best management practice" to install along the stream channel as seen in this photo. This landowner could greatly benefit from the CREP program.

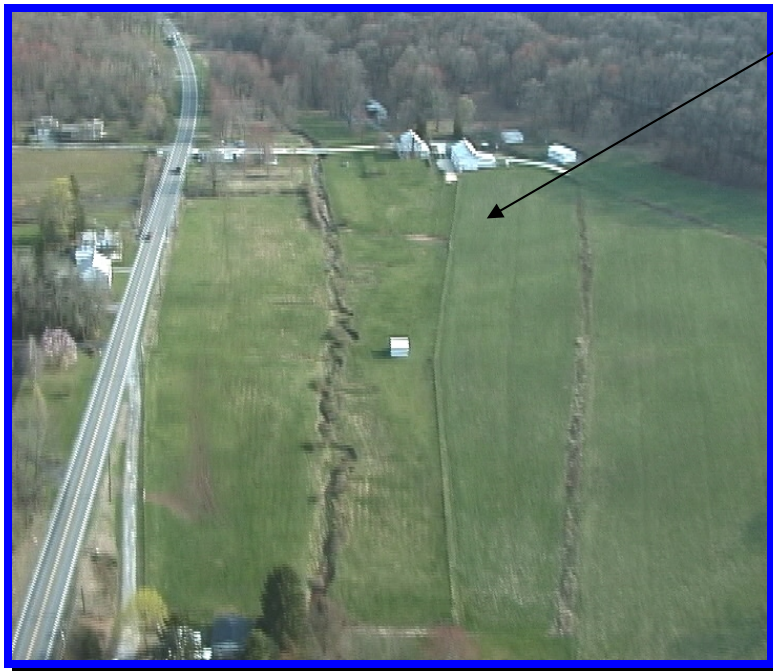
Photo #10 is an aerial view of an active pasture on Tract #21 where livestock have free access to the stream channel. Stream bank fencing and a forested buffer would be beneficial. The stream bank erosion that was evident would likely heal by itself if livestock access was denied. A stone ford cattle crossing could be used to provide access to both sides of the stream and also serve as a watering location. This landowner could greatly benefit from the **CREP** program.

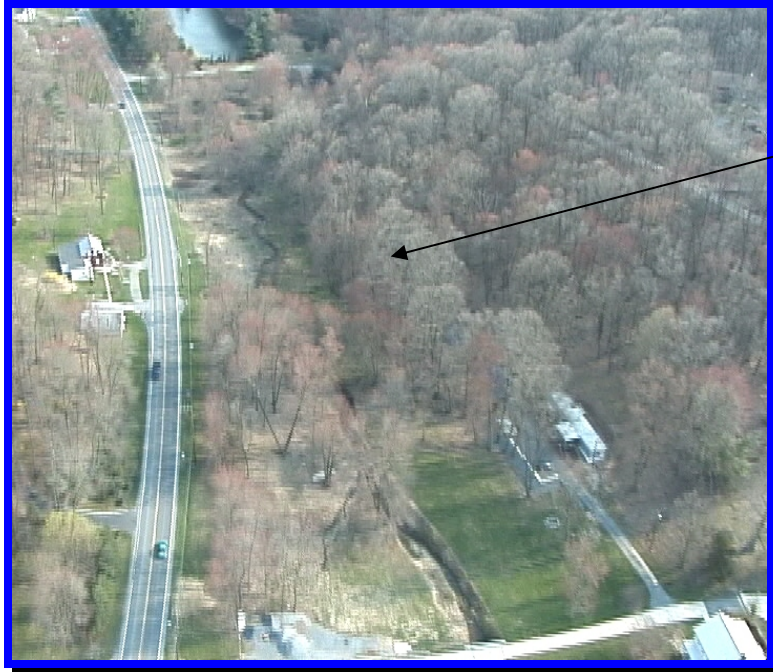
Photos #11 and #12

Aerial view of the large pond at the J. Edward Mack Boy Scout Reservation. Obviously the pond is a source of thermal pollution; a situation that could be improved upon with a bottom discharge. The pond is off line with the stream channel and is believed to be spring fed. Rettew did not find any intake pipe feeding the pond from the stream. It is unlikely the camp would ever want to do away with this manmade pond, considering its value for water related activity – However if opportunity would ever avail itself, the pond could be returned to its likely, former wetland state. It appears the stream channel was realigned to accommodate the pond and Rte. 501.

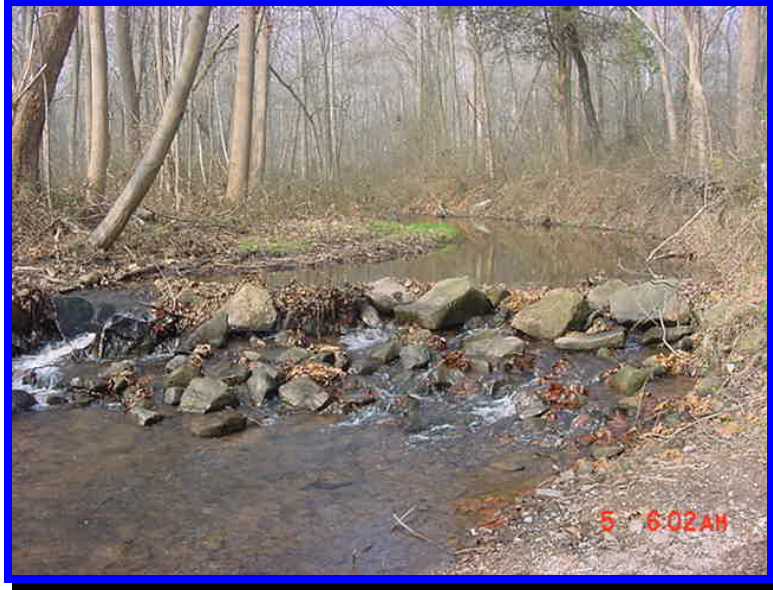
Photos #19 and #20

Photo #20 shows the downstream (southside) end of the PA Turnpike underpass culvert through which both the stream and farm vehicles pass. This culvert also creates somewhat of a migration block in that the substrate is forced to be wide and shallow.

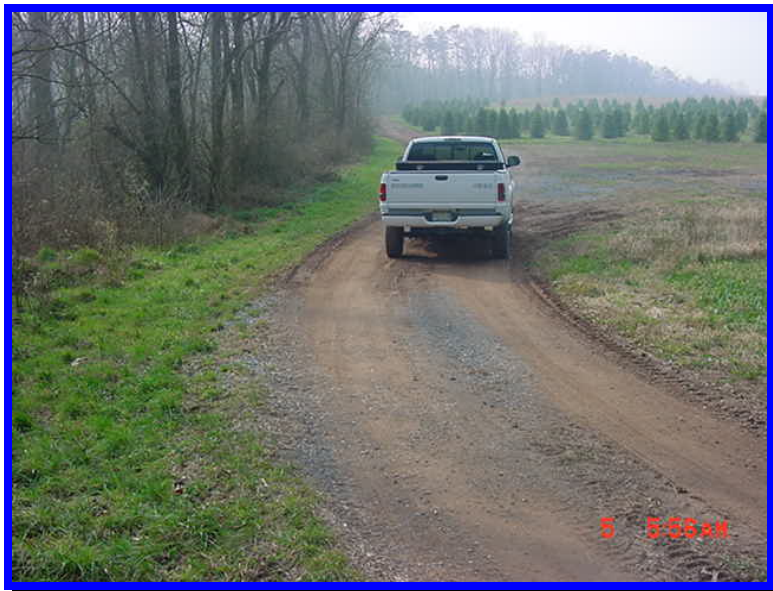
This farm lane on Tract #56 could be improved with various erosion and sedimentation measures so as to avoid sedimentation during rain events. Devices such as broad base dips could divert sediment laden runoff into grass and forest lands for filtering. Grass swales along the lane coupled with culverts could keep upslope water clean and diverted rather than having it enter onto the farm lane.

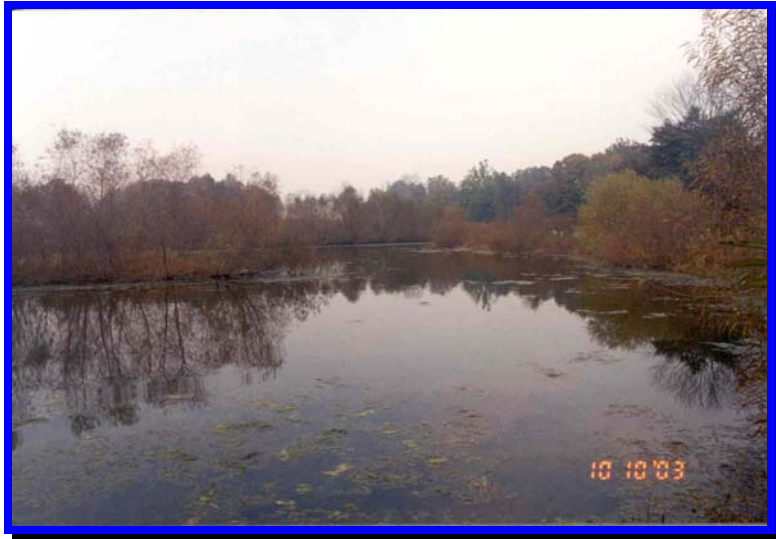
Above – A view of the larger impoundment which serves as a thermal pollution source to Furnace Run.

The trade off of diverting the spring from Furnace Run into the created wetlands is questionable and certainly something that would not have been done in the interest of maintaining a coldwater fishery in Furnace Run. RETTEW suggests diverting the majority of spring flow back into Furnace Run and letting the wetlands become more of a palustrine wetland type rather than the open water condition now so prevalent throughout much of the created wetland area.

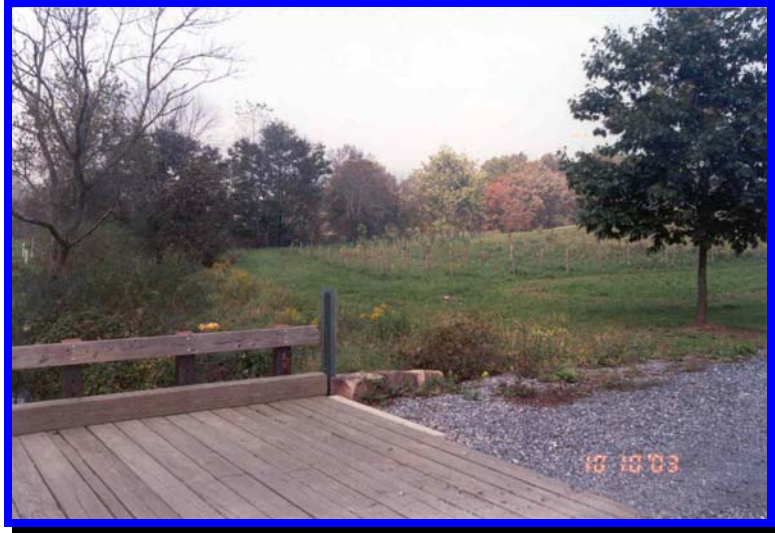
Photos #29 and #30

The new wooden bridge at Elser Hill Road installed by Elizabeth Township with financial assistance from Hopeland Farm and the Commonwealth's Dirt and Gravel Road maintenance program was a much better alternative than the originally planned pipe culvert crossing. The wooden bridge spans the stream channel and allows for a natural substrate underneath the bridge as compared to the metal surface of the inside of a pipe.

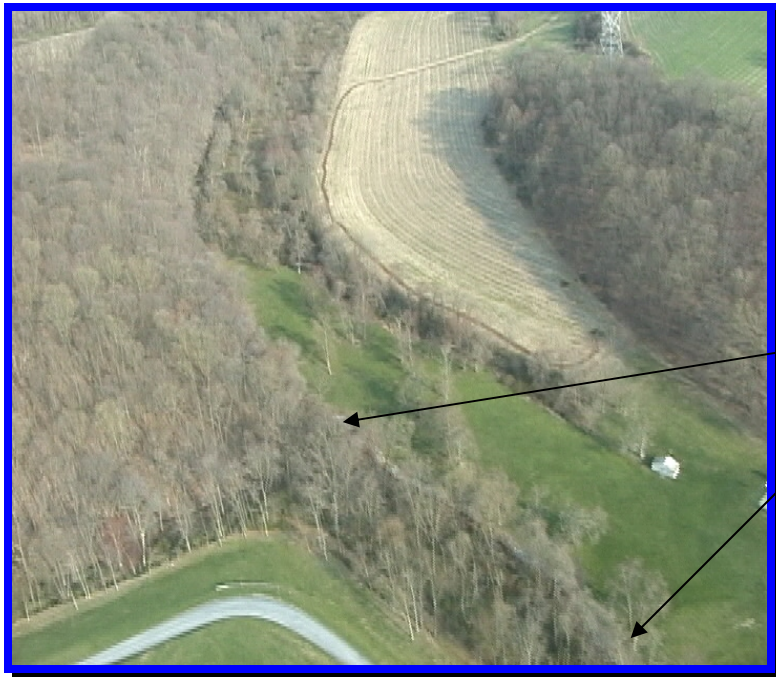
A large section of Furnace Run on Tract #63 has been rip-rapped as can be seen in this photo and photo #43 on the next page. This section of stream was dominated by warm water species including Fallfish.

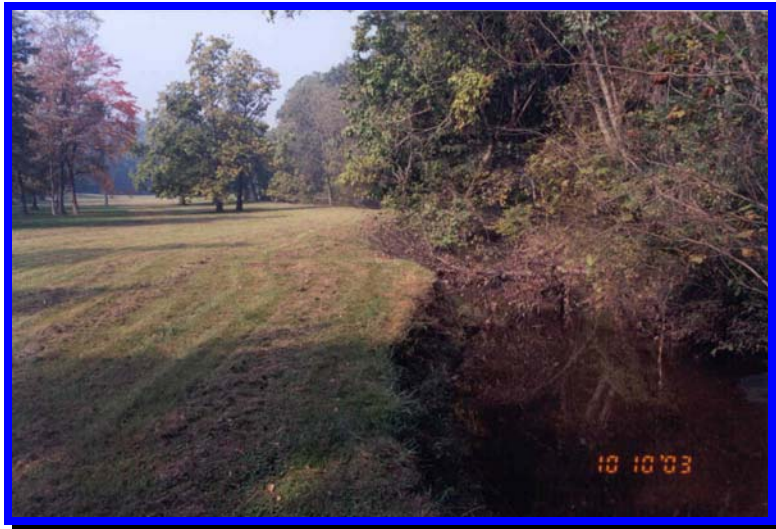
The downstream limits of Tract #63 along Furnace Run. Notice the mowed condition right up to the stream channel. What a great opportunity to put in a well planned forest buffer and instream habitat structures.

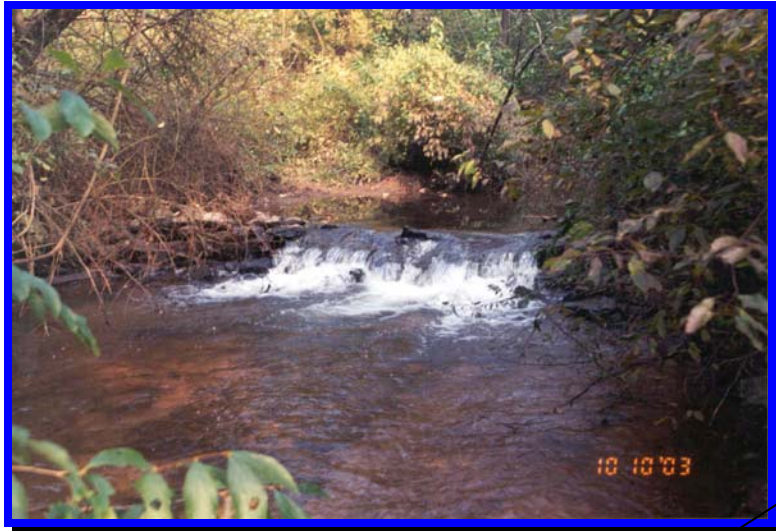
Photos #47 and #48

A view of the small irrigation dam previously mentioned on Tract #64. However it is worth mentioning two (2) native Brook trout were captured within the scour of this small dam.

There is little that can be improved upon within these two tracts other than the removal of a small irrigation dam at the downstream end of Tract #64. Instream habitat is as good if not better than that found in Segloch Run, however the thermal pollution impacts from Tract #63 currently limit the carrying capacity of downstream Tracts #62 and #64.

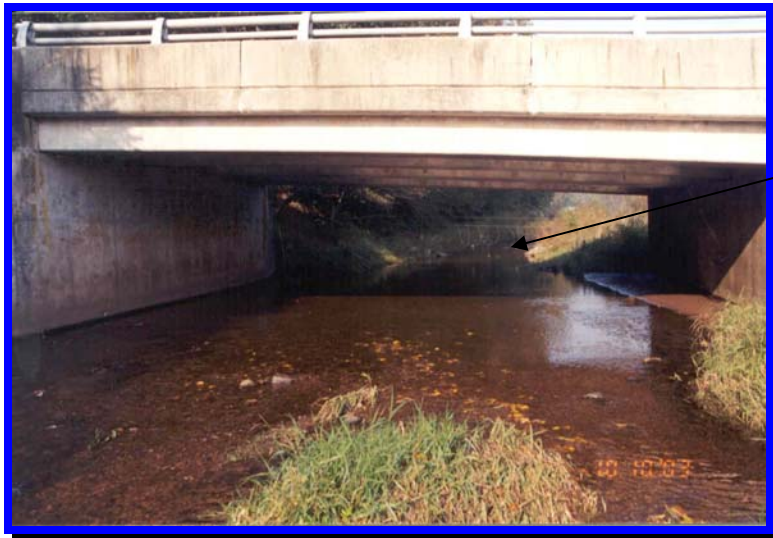
Photos #51 and #52

The way in which the bridge was constructed tends to make the stream wide and shallow, though fish can migrate through the structure in higher flows.

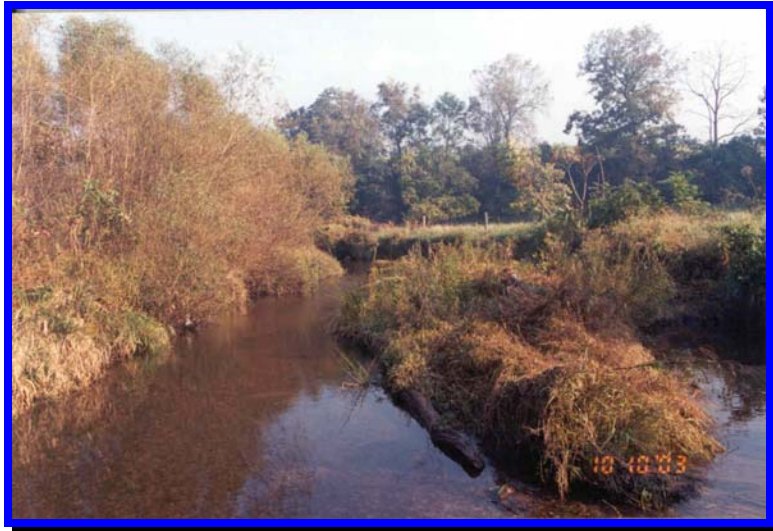
Photos #53 and #54

A view of the downstream end of Tract #78 just prior to Tract #66. Again, one can see evidence of prior damage caused by free ranging cattle prior to the installation of the streambank fencing. This gravel bar will likely continue to grow until one half of the stream channel is closed off and the channel returns to a more suitable width.

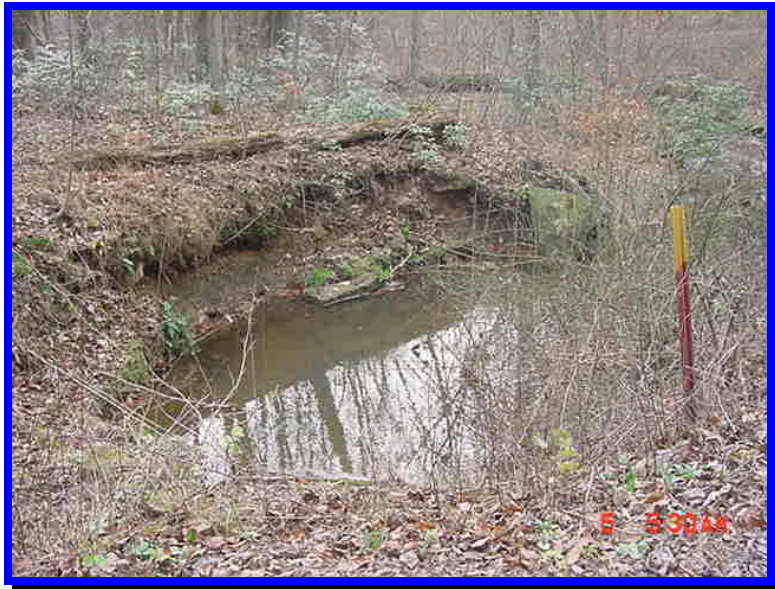
Photo #62 shows bank erosion at the discharge end of the culvert – A problem that could be addressed with better culvert pipe alignment and bank protection such as a mud sill or log cribbing.

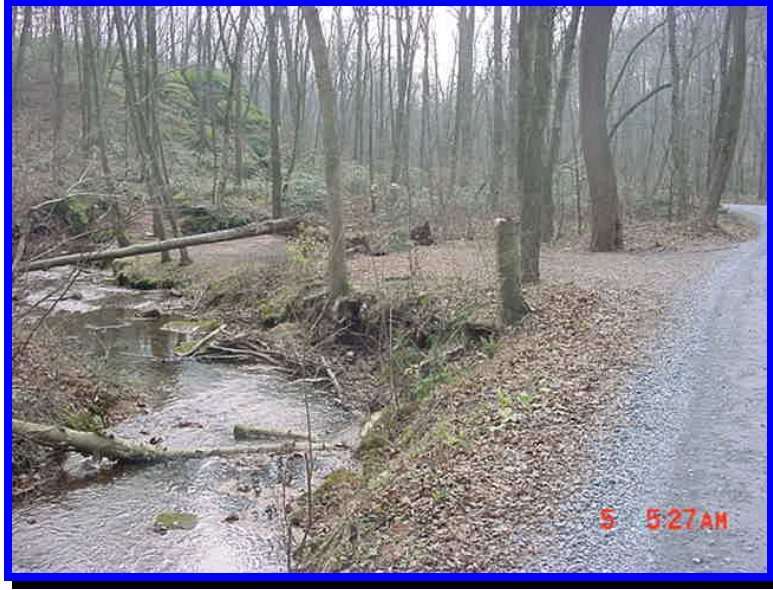
Photos #65 and #66

A pull off area upstream of the bridge on Seglock Road serves as a sediment pollution source to Segloch Run and encourages littering and dumping. The Alliance should work with the Pennsylvania Game Commission to explore possible remedies for such problems.

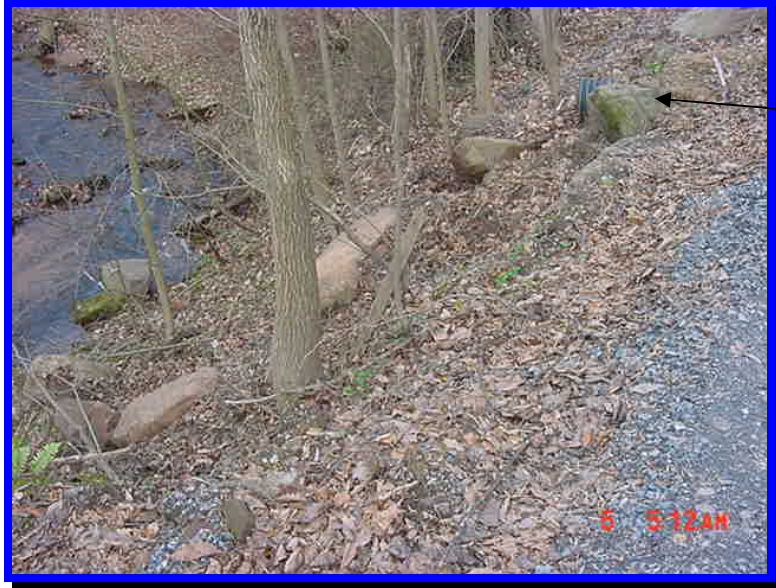
Photos #73 and #74

A poorly placed culvert pipe in Seglock Road. This culvert should discharge at the bottom of the bank rather than the top of the bank. Its current placement will only serve to erode the bank because of the created “waterfall effect” and the absence of any kind of rock apron or rock lined channel to dissipate energy.

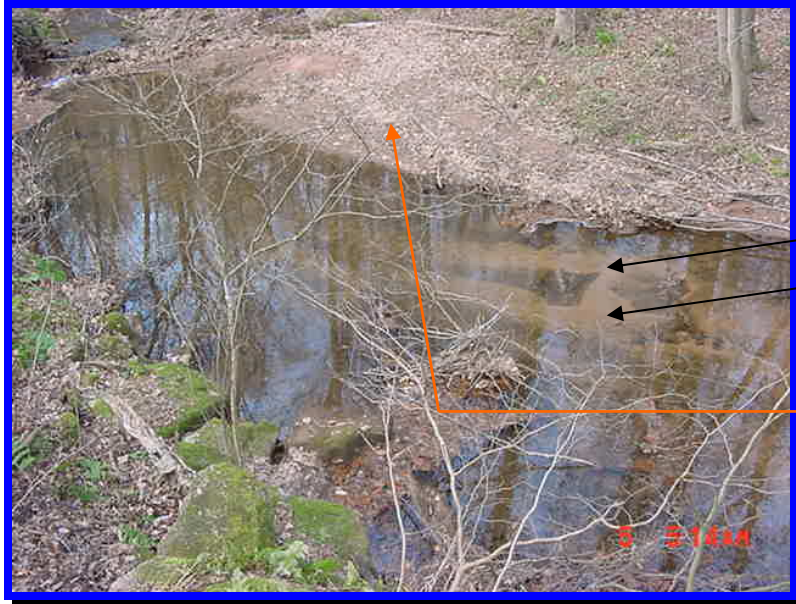
Segloch Run unfortunately has a sedimentation problem as can be seen in this photograph.
