# MACROINVERTEBRATE INVESTIGATION

RETTEW biologists conducted macroinvertebrate sampling at **28 different monitoring stations** strategically located around the Little Conestoga Creek Watershed (as can be seen on the enclosed map). For the record, fish and physical habitat data were also collected at these same 28 monitoring locations/stations.

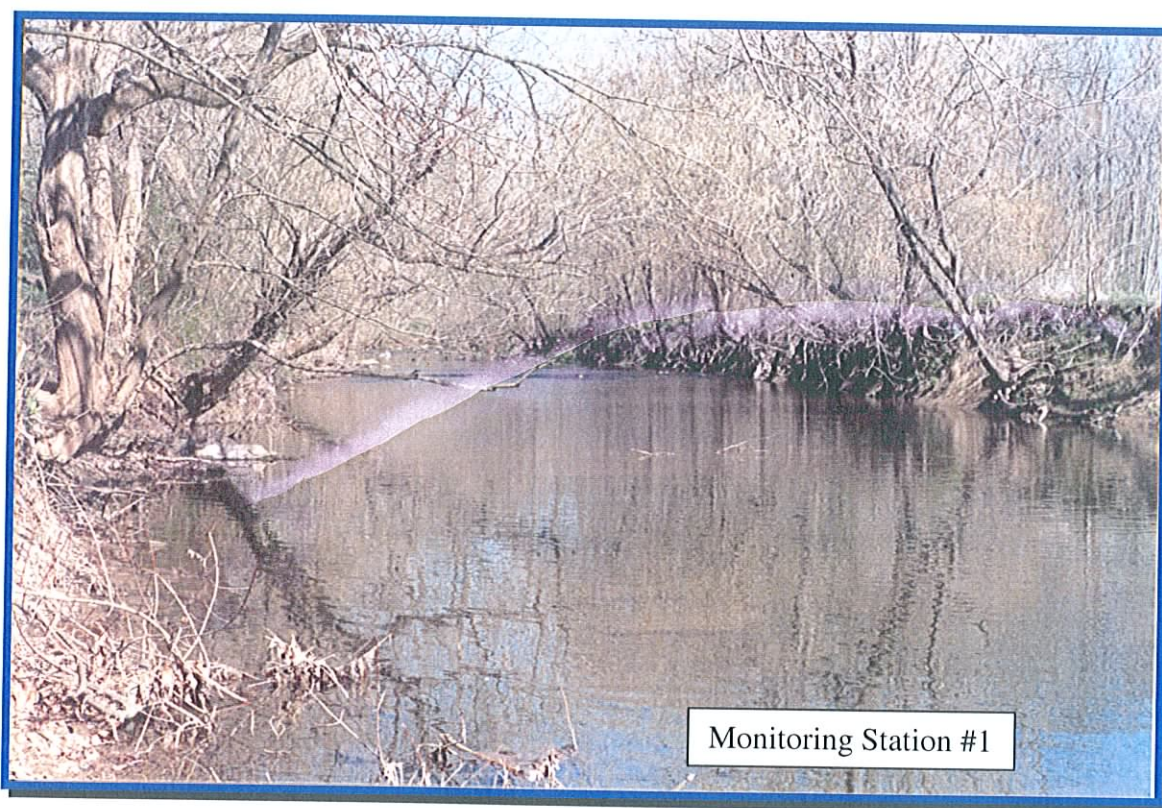
Monitoring stations #1 and #2 are located on the Main Stem at the very bottom of the watershed, with station #1 being located at the confluence with the Conestoga River and station #2 being located approximately 5, 200-feet upstream at the mouth of Indian Run. Both stations exhibited similar in-stream habitat characteristics with station #2 having a better riparian zone of trees and shrubs along its banks. Both pools have sediment free substrates comprised of cobble, boulder and bedrock seams providing good cover for fish and aquatic insects.

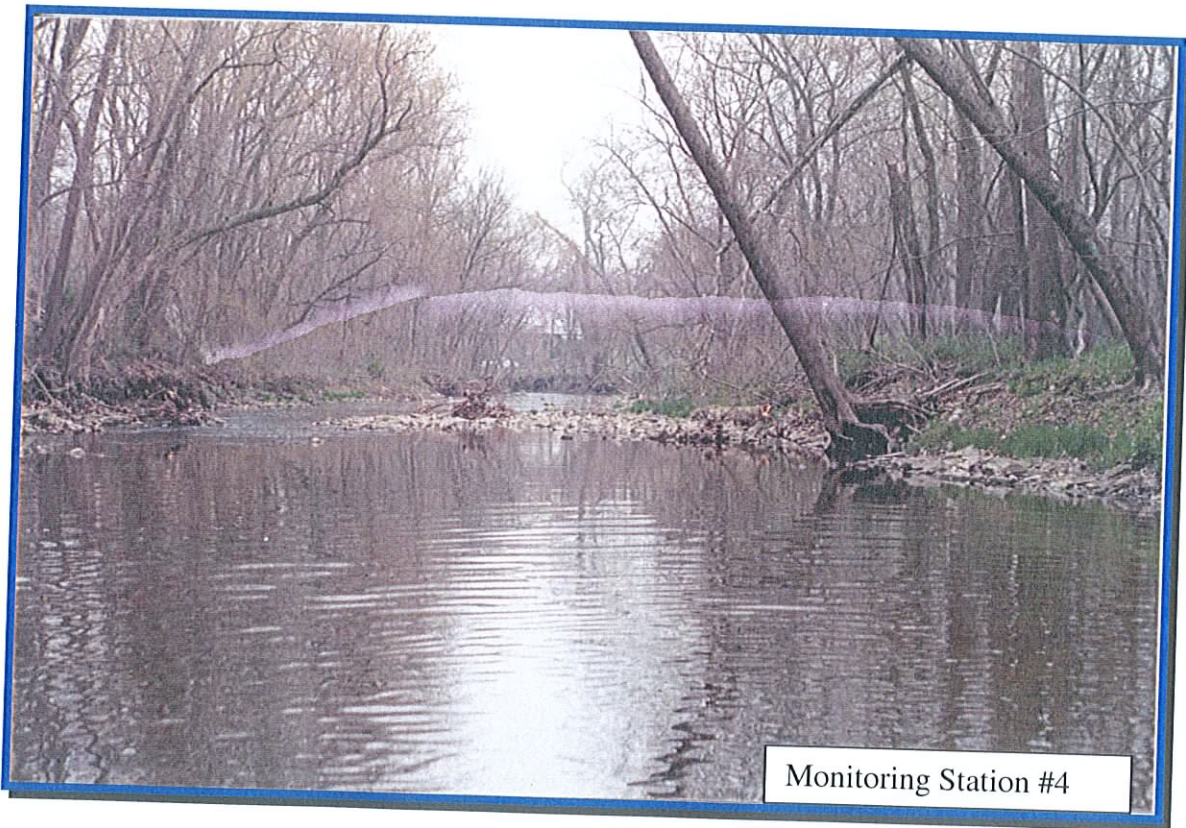
Monitoring Station #4

Monitoring station # 4 is located on the Main Stem at the confluence with the West Branch. This station is located in a very scenic forested valley. Because of its undisturbed, natural stream channel and riparian zone condition, this location should be thought of and used as a reference and/or model for future restoration endeavors in the lower half of the Main Stem. This station exhibits all the “good things” one strives to restore when going about improvement projects – forest buffer, in-stream cover, stable streambanks, sediment free substrate, riffle and pool habitats.

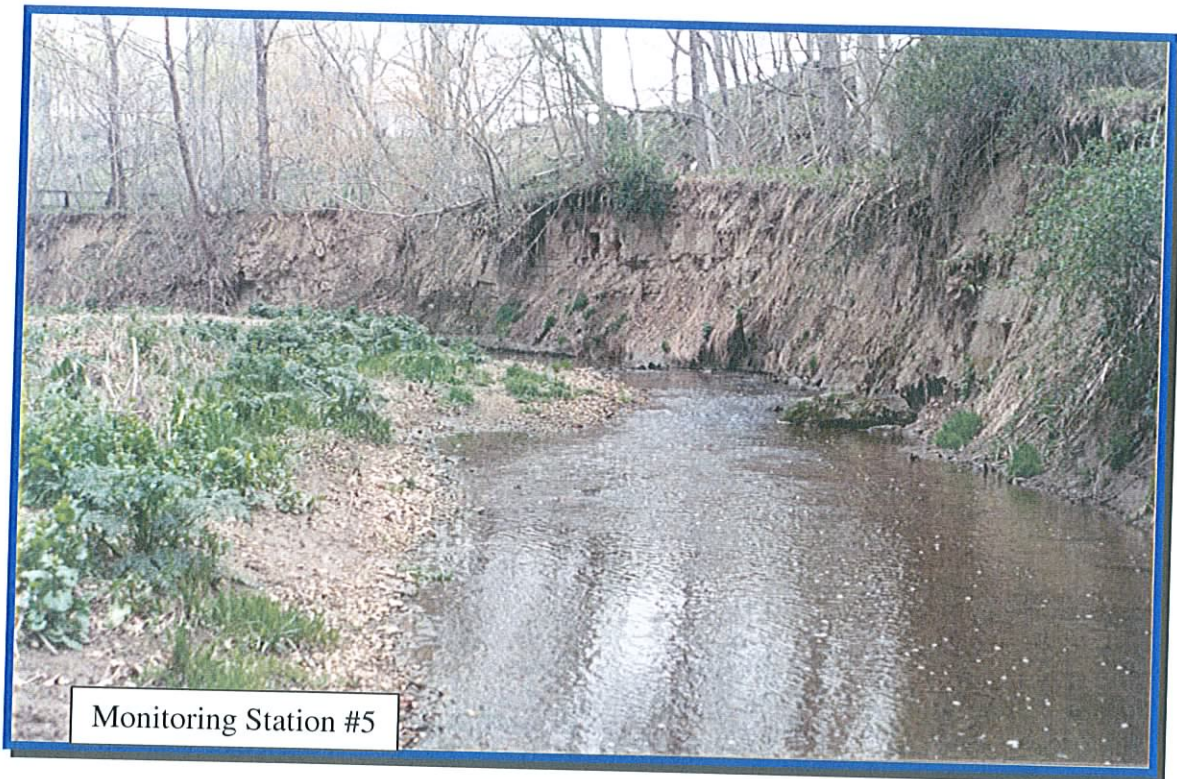
Monitoring station #5 is located on the West Branch approximately 1,000-feet upstream from the confluence with the Main Stem. Remnants of a breached earthen dam are evident in this location, with station #5 being located behind where the dam had once stood. The station is located in a forested valley. The northern streambank is very high (over 10-feet), vertical and eroding at an accelerated rate, while the southern streambank (located on the inside of the stream channel's bend) consists mainly of a large gravel bar gently sloping up into the adjoining woodland. Though the northern streambank is eroding, it none-the-less provides great fish habitat in its undercuts. Still an effort should be made to stabilize the northern bank.

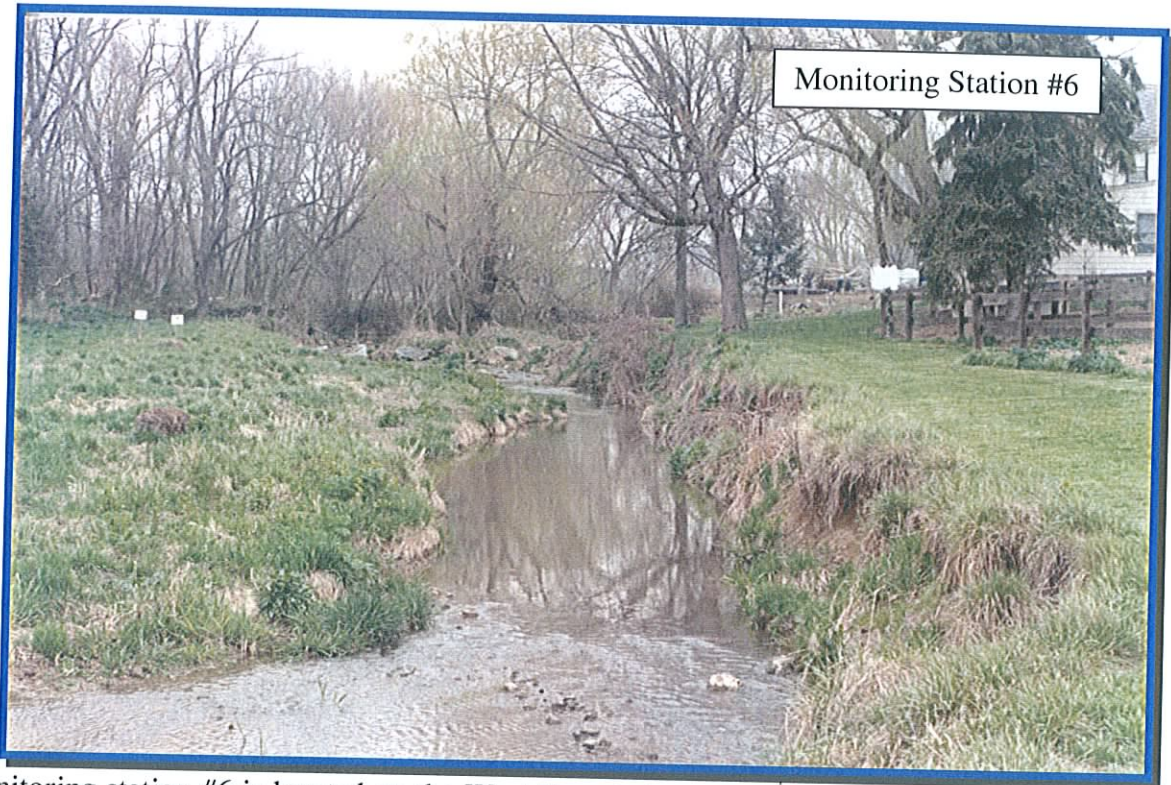
Monitoring station #6 is located on the West Branch just upstream of Bender Mill Road in farm country. Here the West Branch is obviously impacted by the surrounding agricultural landuse. Streambank erosion is occurring on both banks and little exists in the way of a forest buffer; rather much of the area adjacent to the stream is either in pasture or consists of mowed grass fields. This reach of stream could be vastly improved by simply planting an adequate forest buffer.

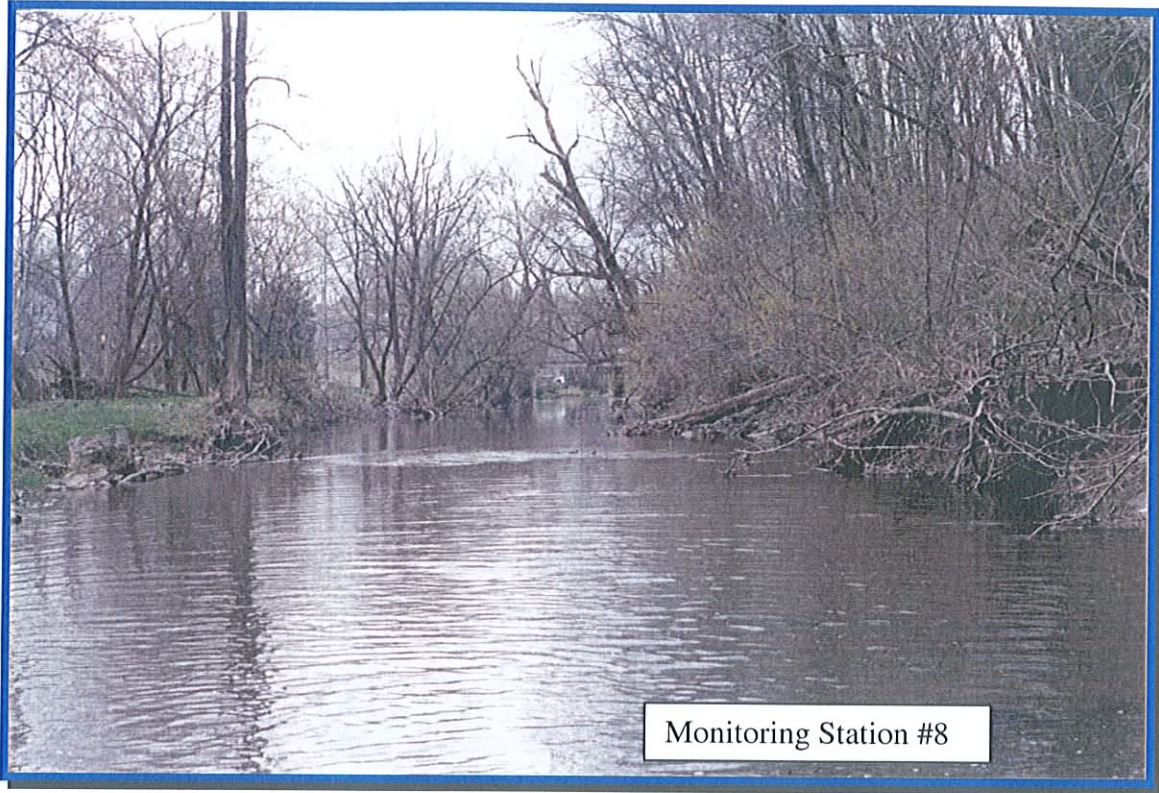
Monitoring station #8 is located on the Main Stem upstream of Route 999 “Blue Rock Road”. The western streambank is steeply sloped and forested, while the eastern bank gives way to a large floodplain serving as backyards to adjoining properties. This reach a stream scored very high in most of the evaluated habitat parameters, coming in second best when compared with the other stations. Long deep pools with woody debris for fish cover characterized this location.

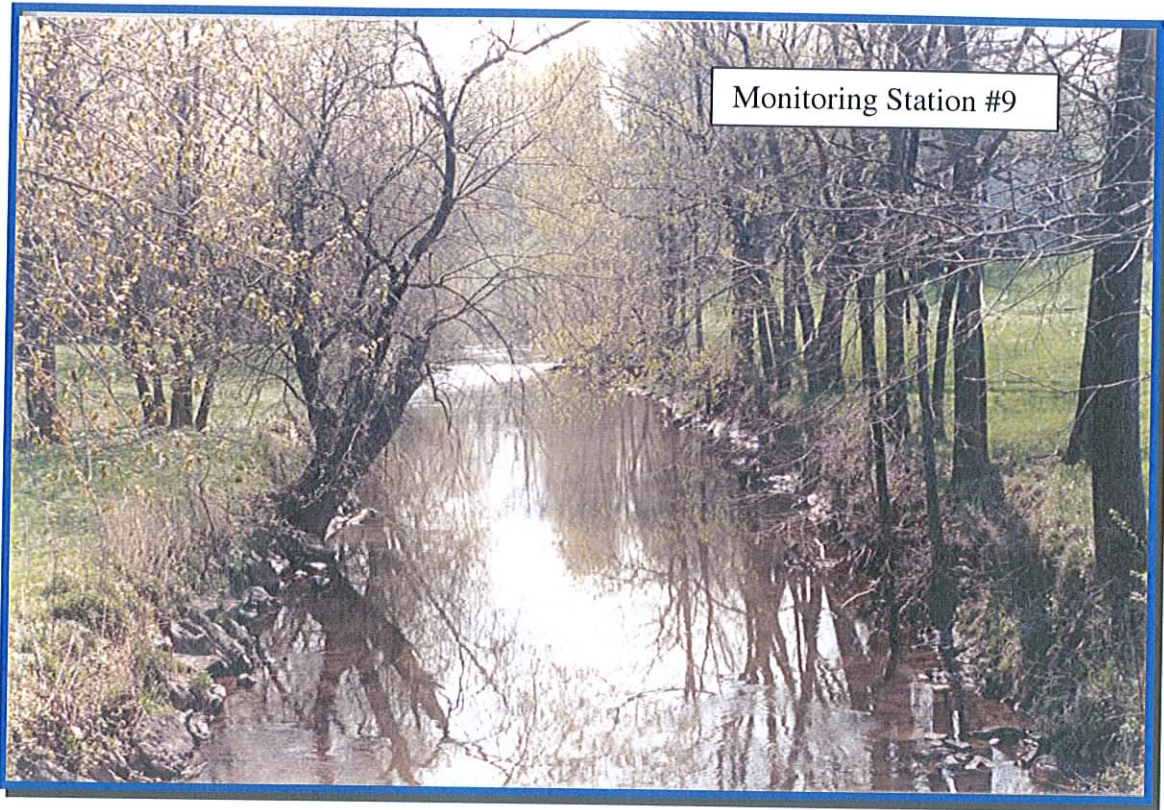
Monitoring station #9 is located on the Main Stem in Manor Park just downstream and south of Charlestown Road. Much of the stream in this area is immediately bordered by mowed lawn. Only a few larger trees line the streambank, native shrubs and other herbaceous plants are rare. Obviously the forest buffer in this area could be much improved. In-stream cover was adequate for smaller fish, but larger cover structure for larger fish such as Smallmouth bass was limited.

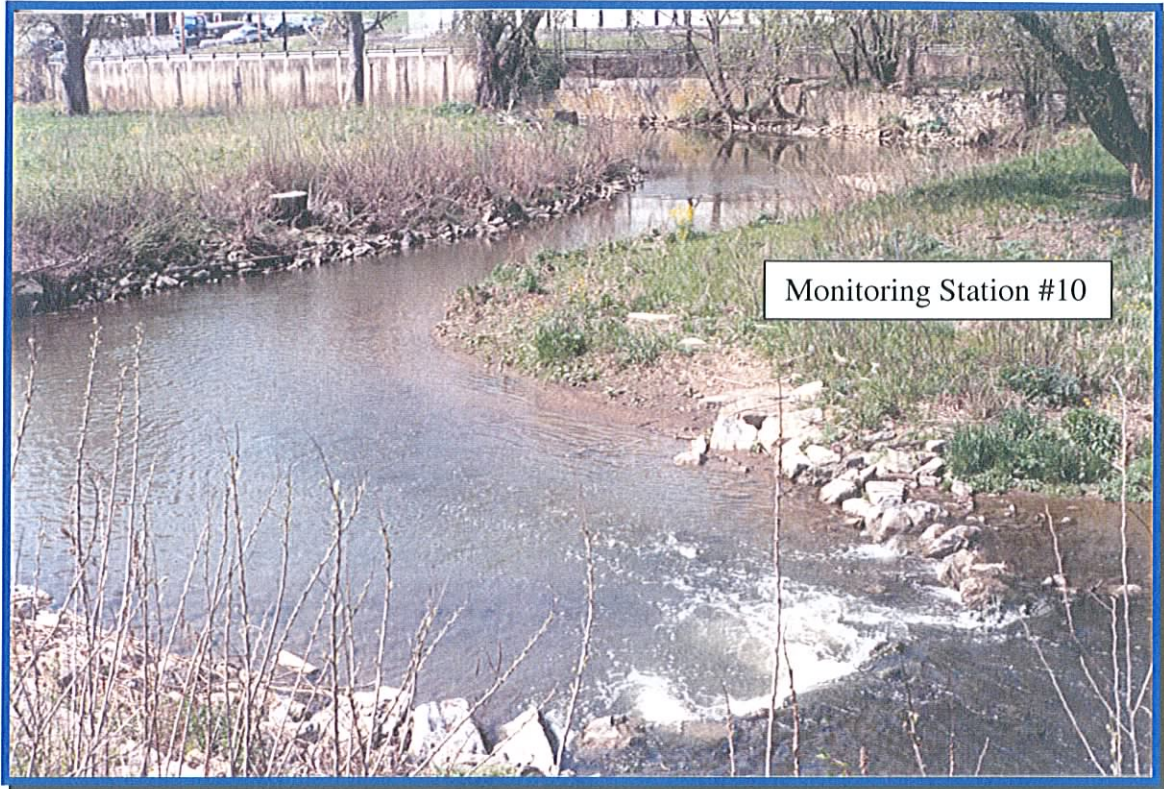
Monitoring station #10 is located on the Main Stem within Maple Grove Park just south and downstream from Route 462 "Columbia Avenue". This area has recently undergone some habitat improvement work consisting of a forest buffer planting and stream channel stability measures such as the rock cross-vane depicted in the above photograph. The habitat quality in this reach of stream should improve somewhat as the forest buffer matures. However, the western streambank below the Maple Grove Mill building consists of a vertical concrete wall that will likely continue to limit site recover unless it is removed and the natural streambank restored.

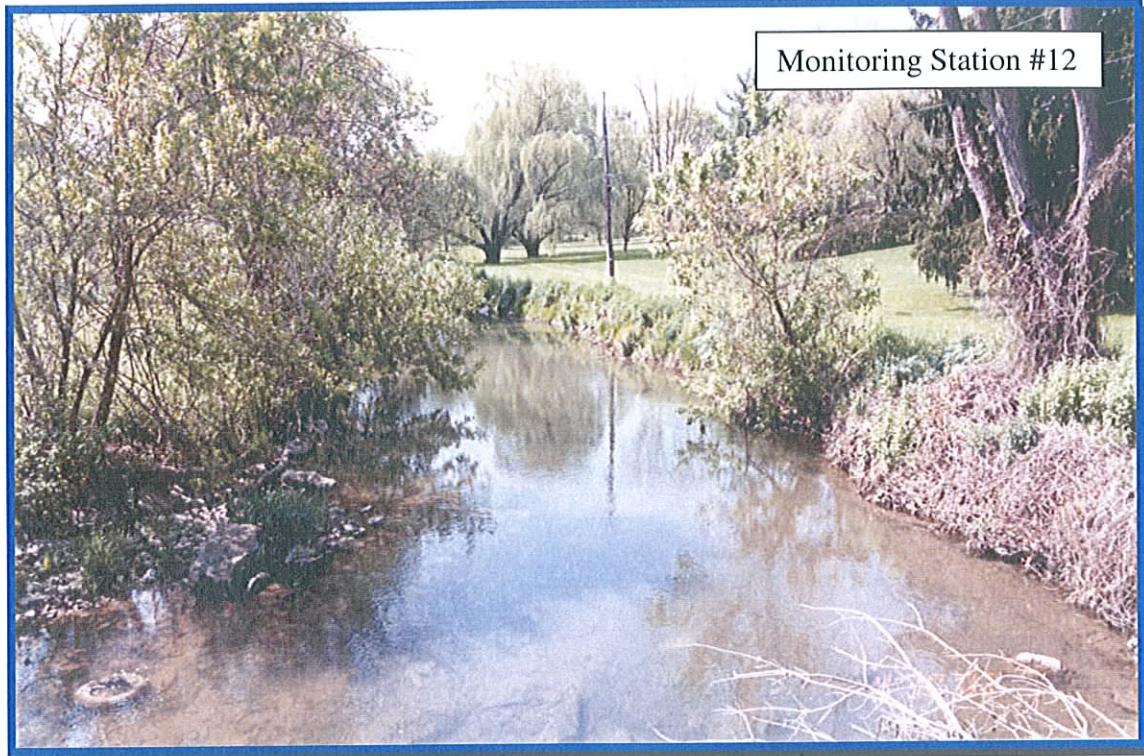
Monitoring station #12 is located on the Main Stem immediately downstream of Route 23 “Marietta Pike”. This section of stream is located in a residential setting where backyard lawns encroach right up to the top of the streambank, offering little in the way of forest buffer and riparian habitat. Habitat under the water and within the channel isn’t any better. Much of the substrate is sediment laden and little overhead cover exists for larger fish.

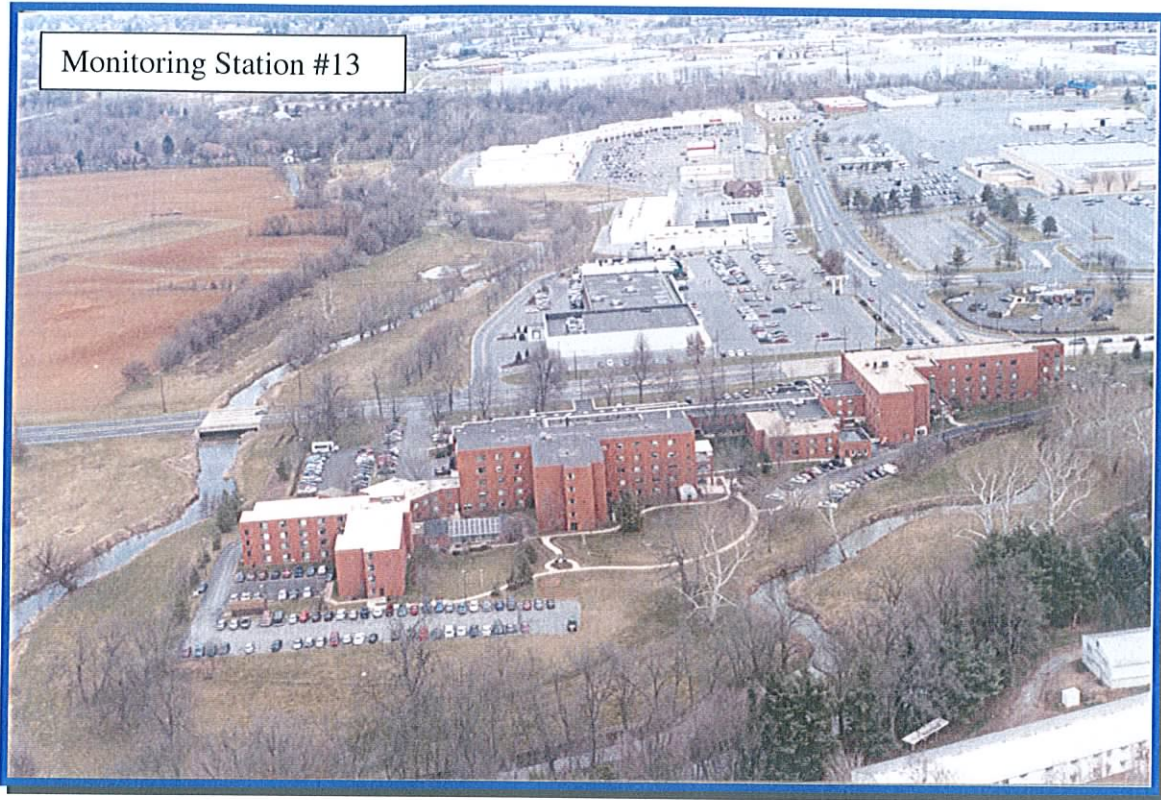
Monitoring station #13 is located in an urban/commercially developed setting on the upstream side of the Old Harrisburg Pike near Park City. The lack of in-stream cover for fish and the tightly embedded, sediment laden substrate really limits fishery potential in this Main Stem reach. Litter was quite common. The majority of the Park City shopping complex does not have any sort of stormwater management in the way of detainment. The stream channel in this location shows signs of streambank erosion due to flashy stormwater flooding events. The stream channel is very wide compared to its overall depth and baseflow depth. The channel is overly wide to accommodate flashy flooding events.

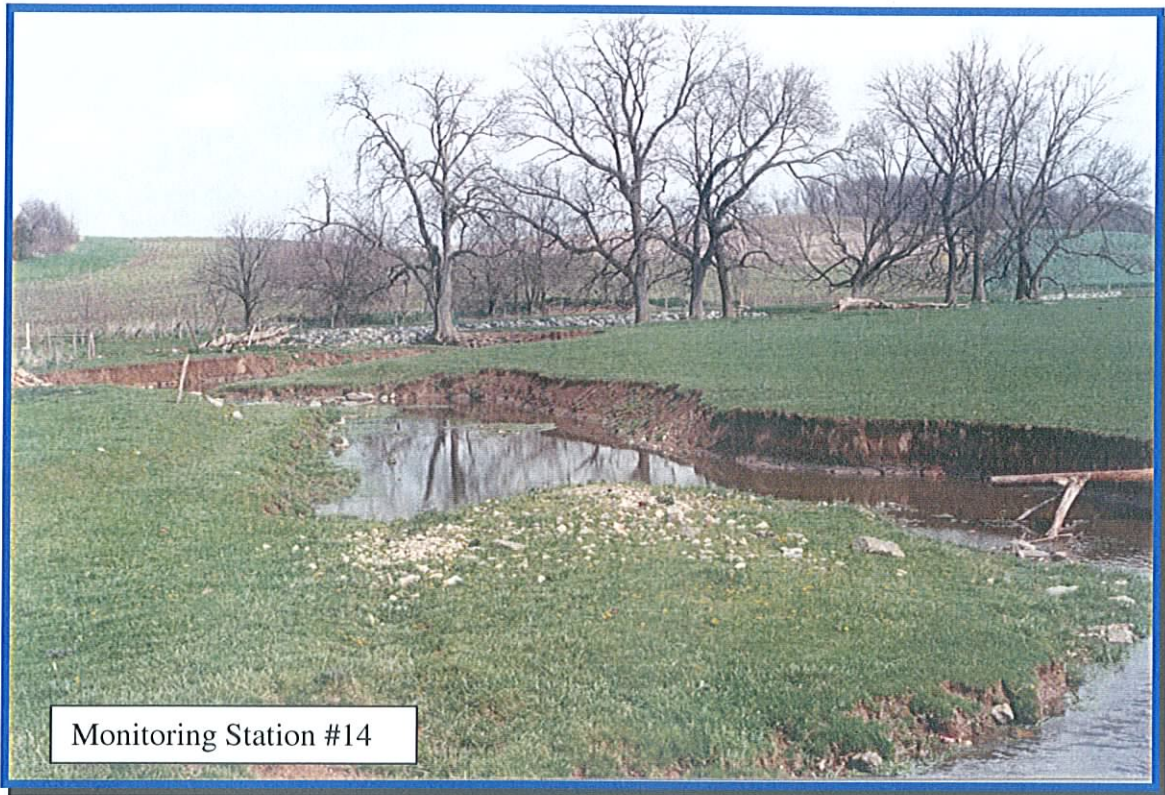
Monitoring Station #14

The worst monitoring station in regards to habitat quality was station #14 located immediately downstream of State Road in East Hempfield Township. Station #14 is located in a pasture where dairy heifers have free access to Swarr Run. The pastureland is severely overgrazed and streambank erosion is excessive. Swarr Run's substrate in this local is sediment-laden and severely trampled by wading livestock. No other single farm within the entire Little Conestoga Creek Watershed exhibited such an overwhelming abuse of the stream and riparian zone. Other farms have "hot spots", like a small feed lot or exercise lot, but no other single farm impacts over one-half mile of stream corridor!

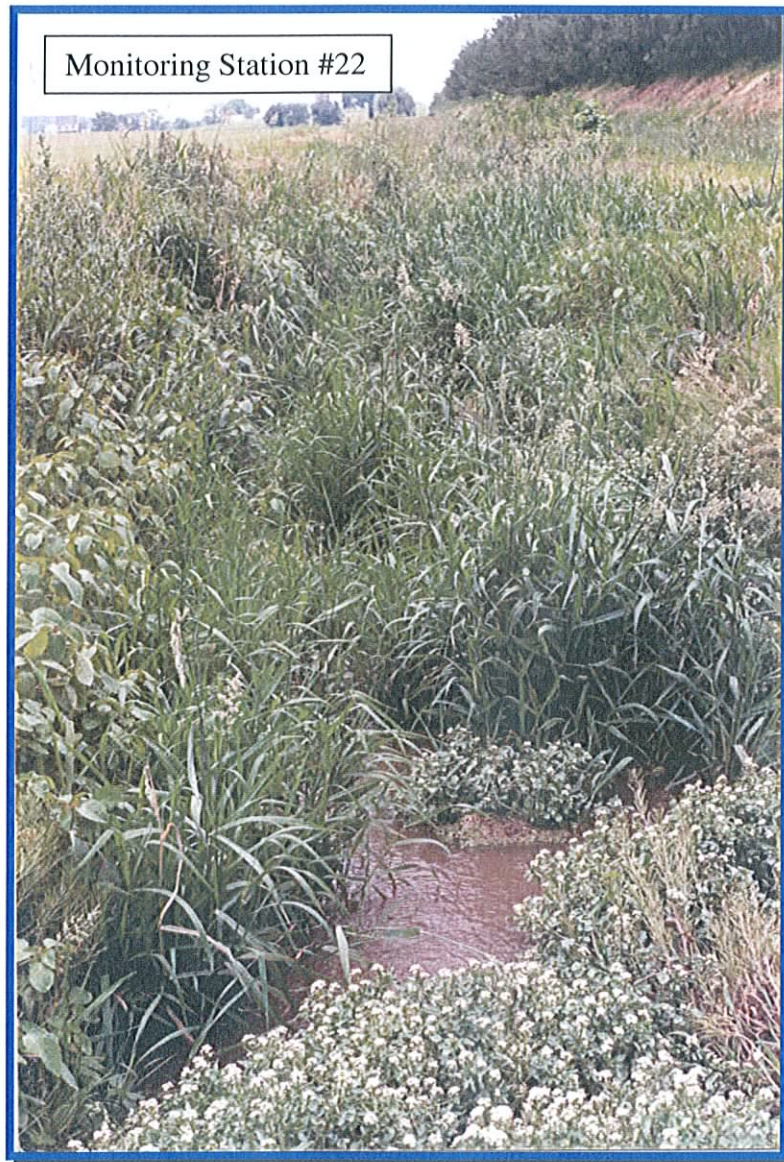
Amish farm downstream from monitoring station #22 – Notice how stream gets immediately wider when it enters the pasture (due to excessive trampling of streambanks and sediment deposition within the channel)

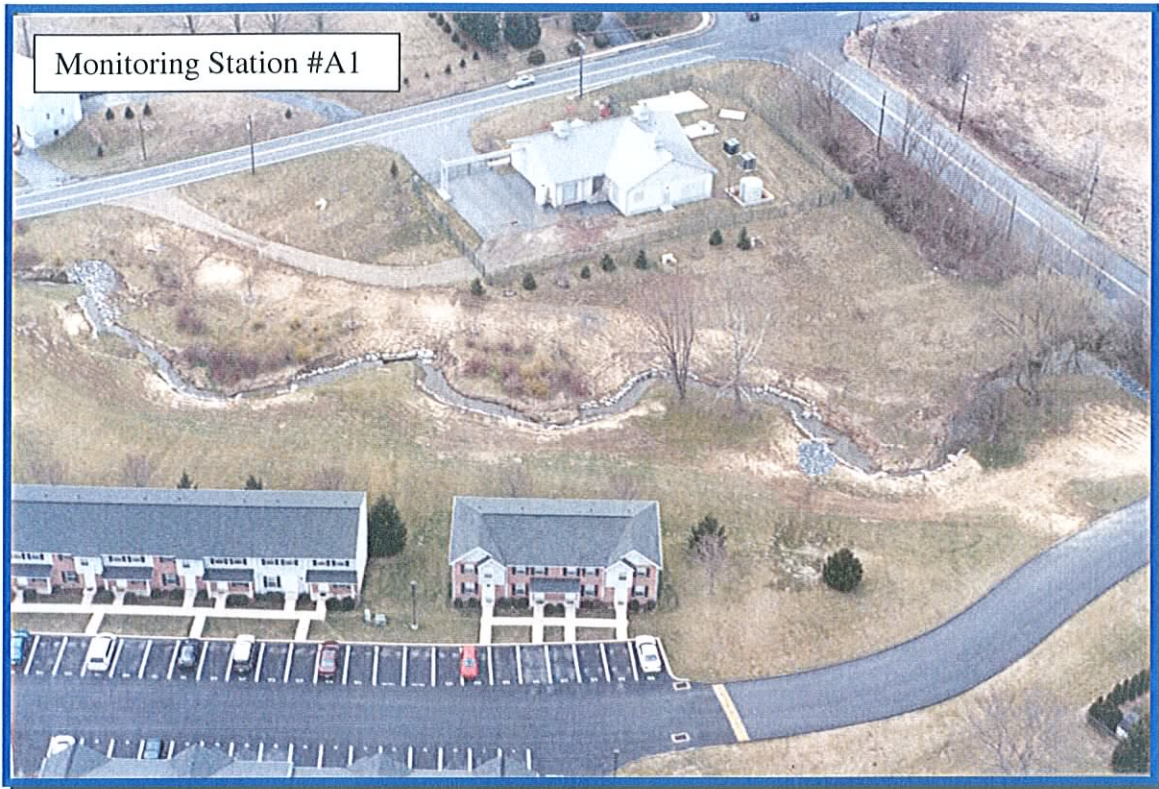
Monitoring station #A1 is located on an un-named tributary located just north of Charlestown Road in Manor Township. The above pictured section of stream (where station #A1 is located) was the site of a recent (spring 2002) stream restoration project by the Little Conestoga Watershed Alliance. RETTEW Associates, Inc. provided project design and construction oversight. This section of stream previously suffered from severe streambank erosion due to ill-managed stormwater and the encroachment of lawn mowers into the riparian zone. The restoration project included a forest buffer planting, bioengineering, and the installation of rock weirs, mud sills and boulder placements to provide channel stability and fish habitat. After one growing season and some rather intense storm events, all improvements seem to be doing fine.
