## IMPAIRED STREAM SEGMENTS

# Little Conestoga Creek Impaired Stream Segments

# SOURCES AND CAUSES OF IMPAIRMENT

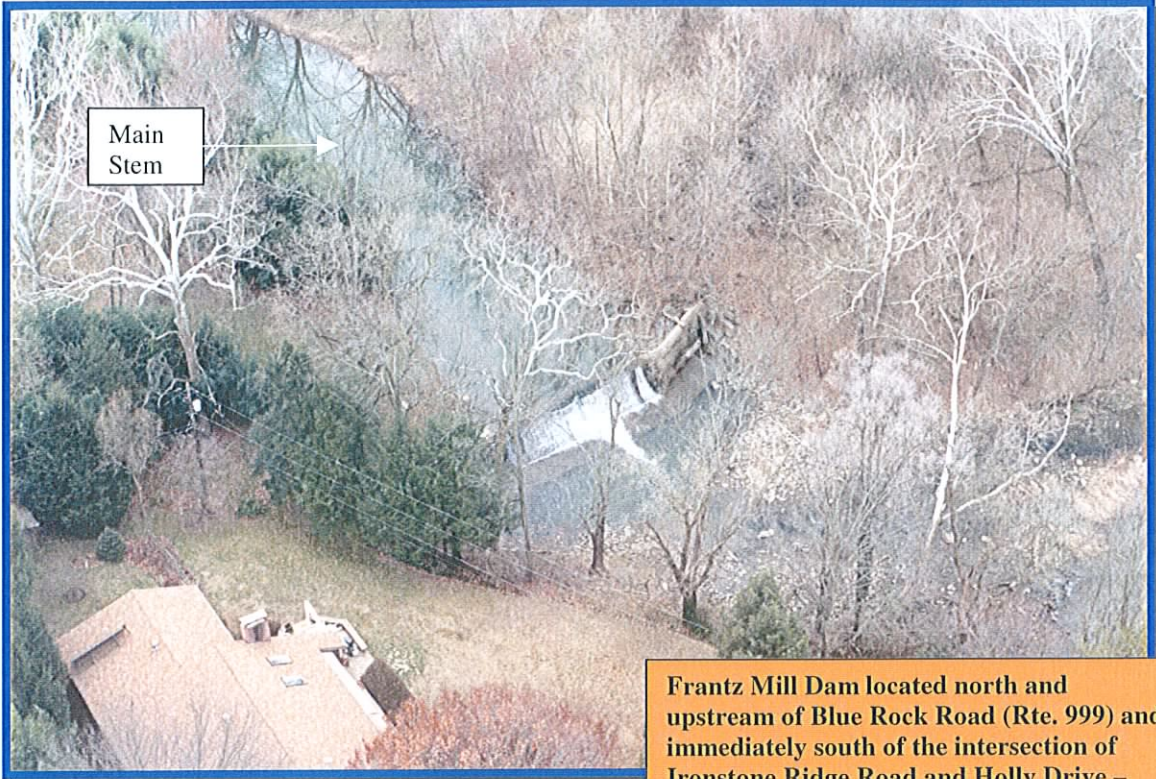
Frantz Mill Dam located north and upstream of Blue Rock Road (Rte. 999) and immediately south of the intersection of Ironstone Ridge Road and Holly Drive – The dam is most easily viewed from Ironstone Ridge Road – The dam is currently a migration blockage for fish and creates a localized sedimentation problem for at least 2,500-feet upstream - The dam no longer serves its original function of providing water power to a nearby mill

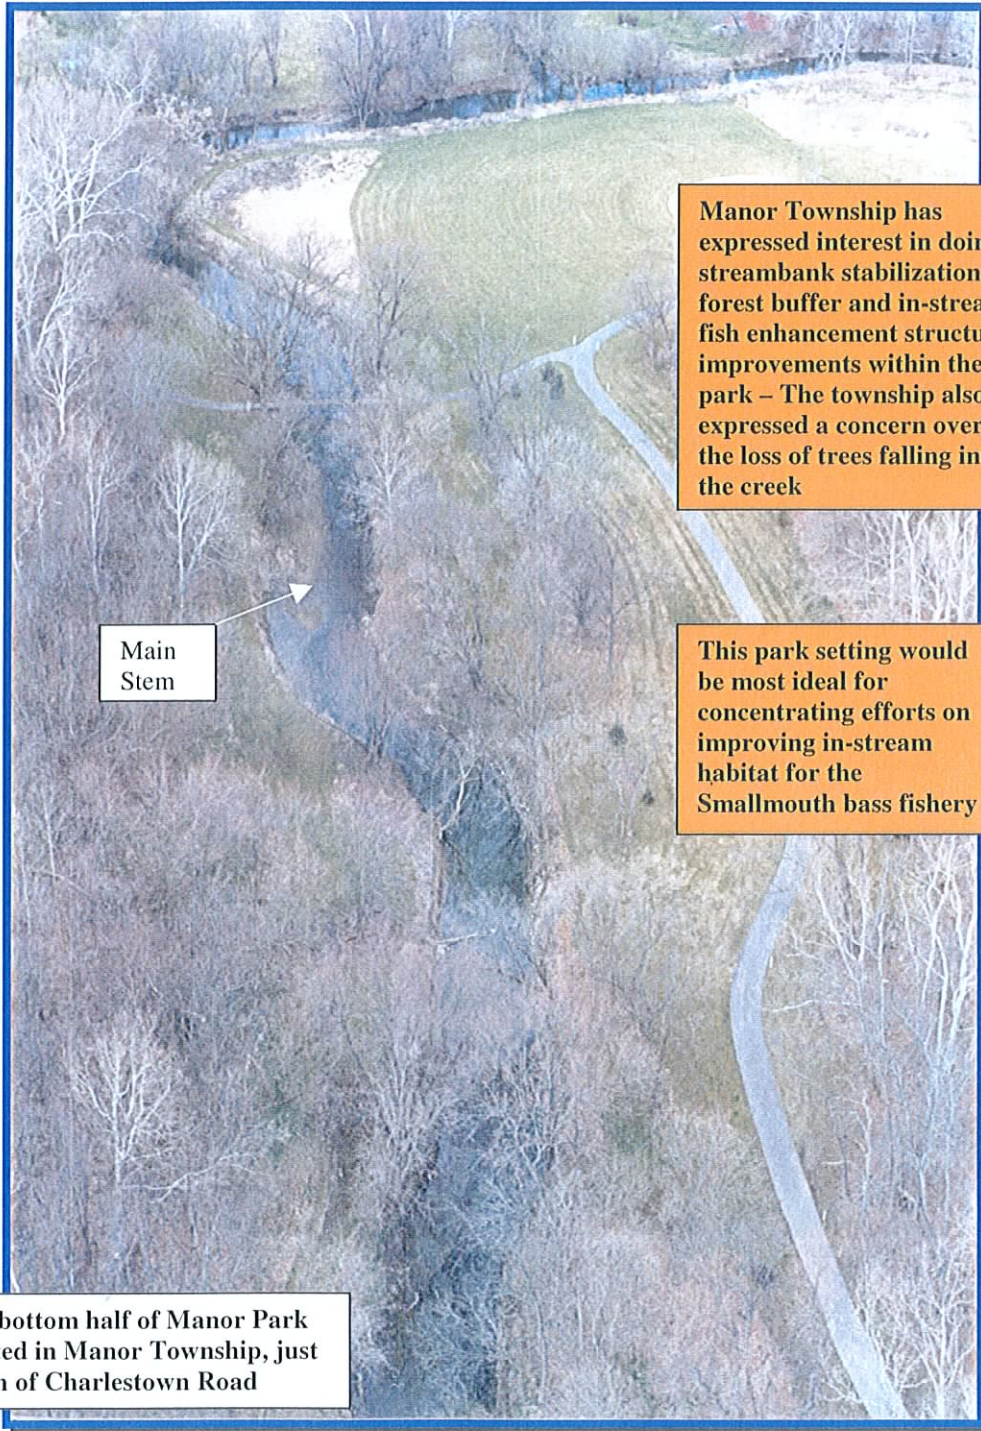
The bottom half of Manor Park located in Manor Township, just south of Charlestown Road

Streambank erosion and falling trees is a problem in several locations throughout the park

Manor Township has expressed interest in doing streambank stabilization, forest buffer and in-stream fish enhancement structure improvements within the park – The township also expressed a concern over the loss of trees falling into the creek

This park setting would be most ideal for concentrating efforts on improving in-stream habitat for the Smallmouth bass fishery

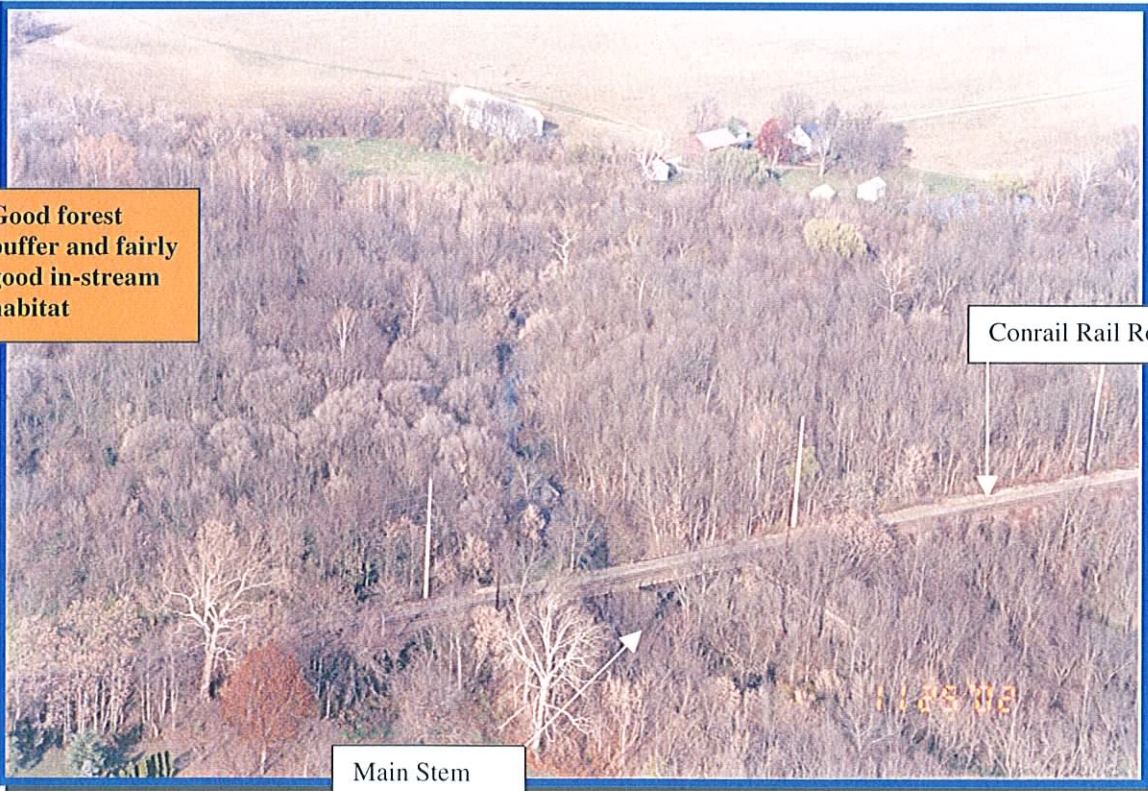
Good forest buffer and fairly good in-stream habitat

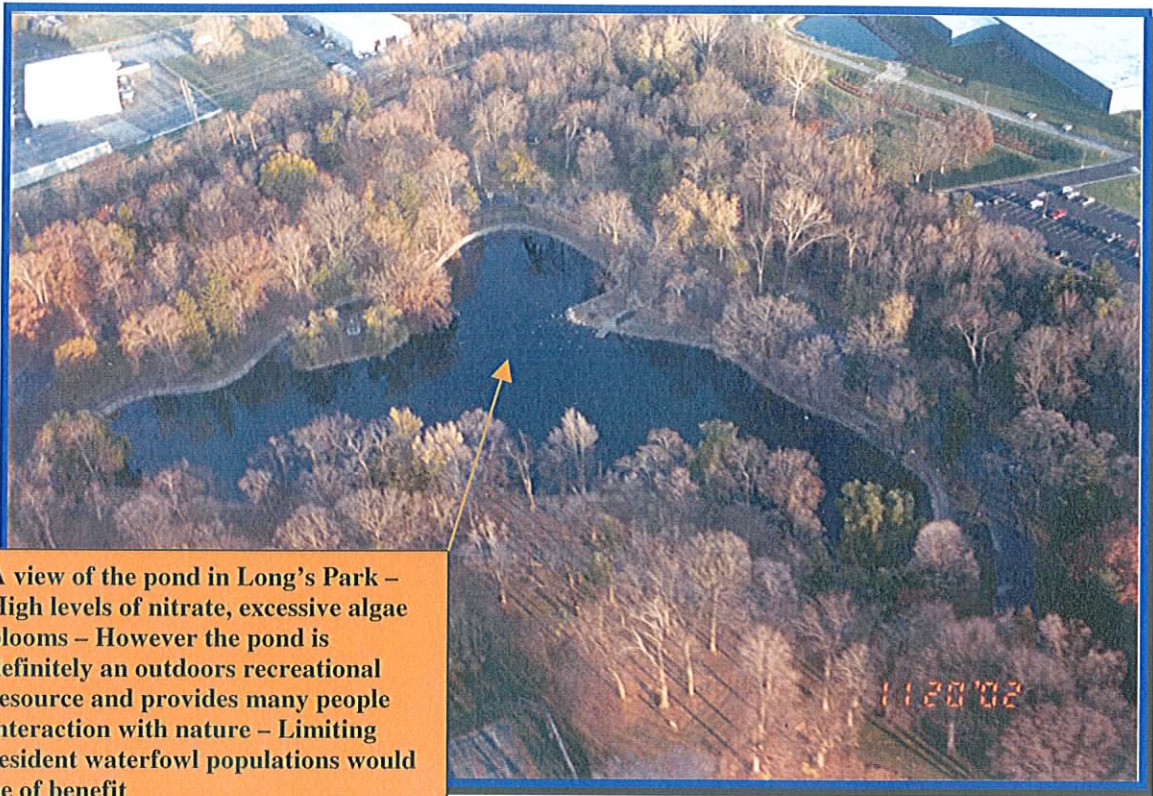
A view of the pond in Long's Park – High levels of nitrate, excessive algae blooms – However the pond is definitely an outdoors recreational resource and provides many people interaction with nature – Limiting resident waterfowl populations would be of benefit

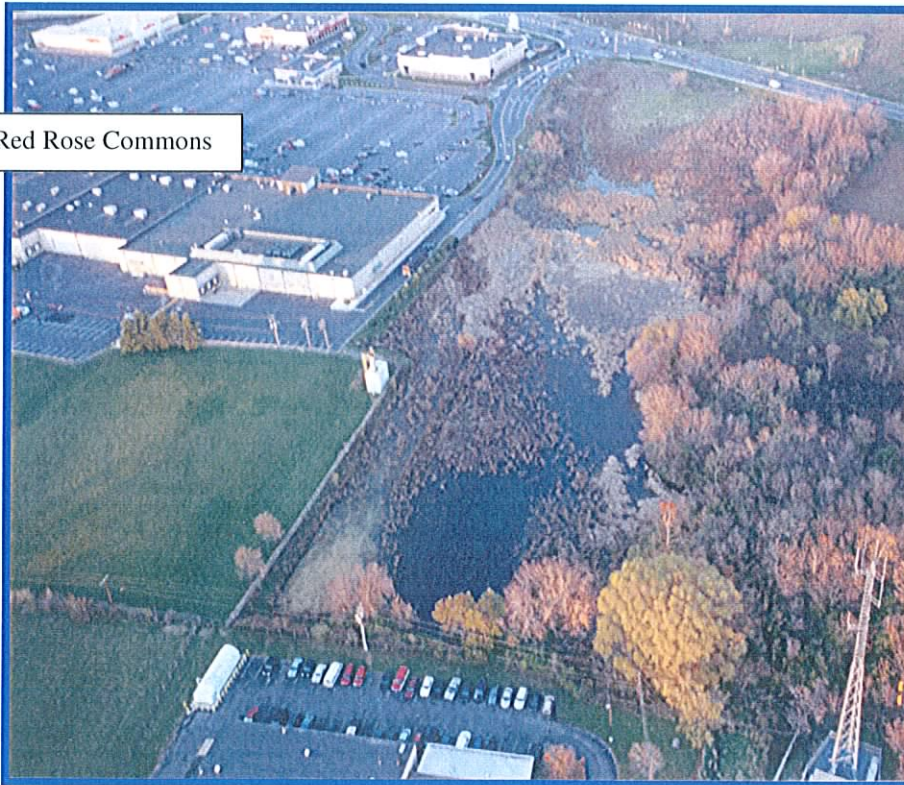
A view of Dillerville Swamp and Red Rose Commons – See plans for spraying and controlling invasive Purple loosestrife in “Completed Restoration Projects” chapter of this report for further details – Dillerville Swamp is now but a fraction of the once incredibly diverse wetland habitat it once was – Franklin and Marshall College had in the past completed extensive flora investigations within the swamp and had identified several rare, threatened and endangered plant species – Recent investigations indicate a loss of these plant species – A unique opportunity exists for restoring the original plant community

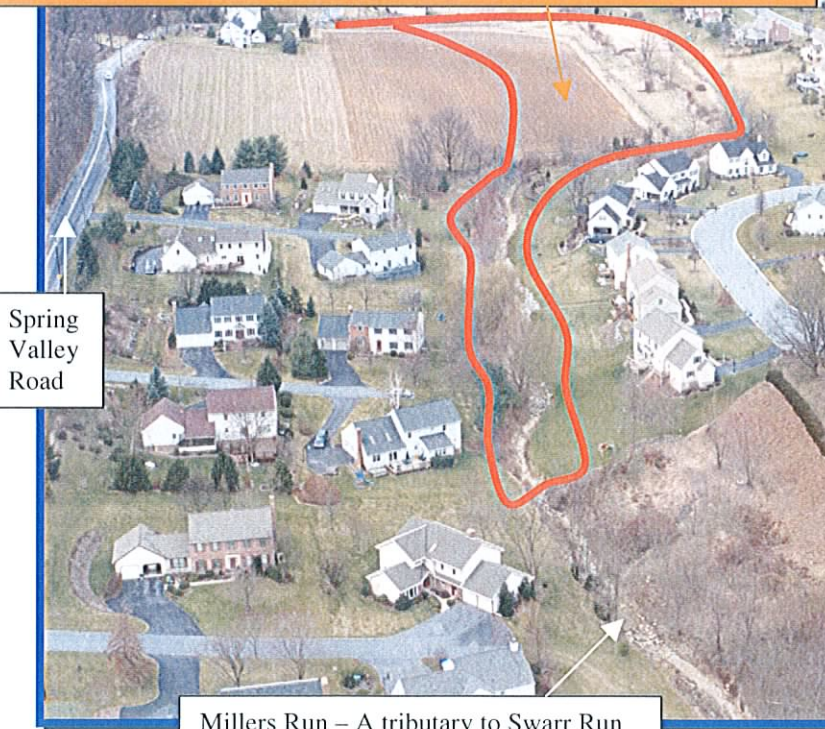
Millers Run – A tributary to Swarr Run

Site of future improvement work funded by received “Growing Greener” grant – This section of Millers Run as well as downstream reaches are severely eroded due to stormwater erosion – Much of the area was developed prior to Lancaster County adopting a stormwater management ordinance – Retrofitting stormwater management facilities, stream bank erosion repairs and forest buffer installations are needed throughout much of this sub-watershed

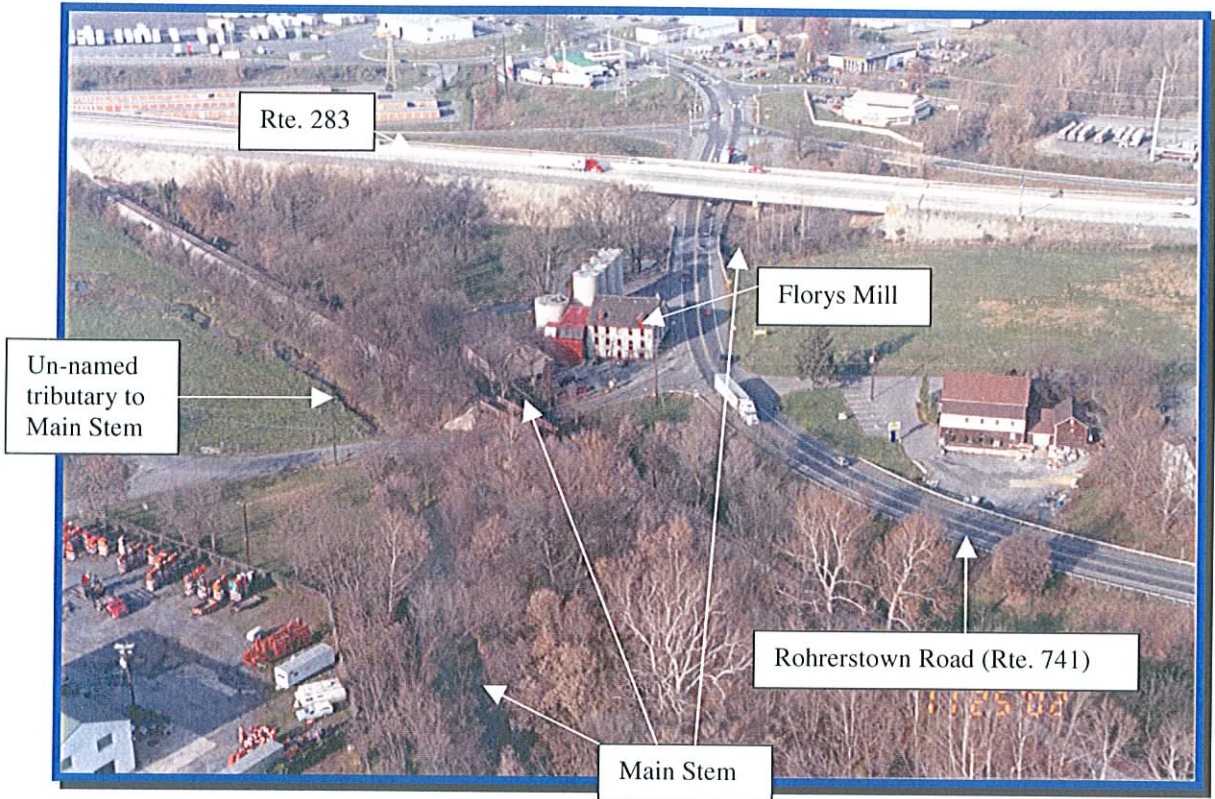
Florys Mill area – Photograph of same un-named tributary pictured above

Kolb Farm – Received streambank fencing and forest buffer installation care of the Lancaster County Academy in 1997

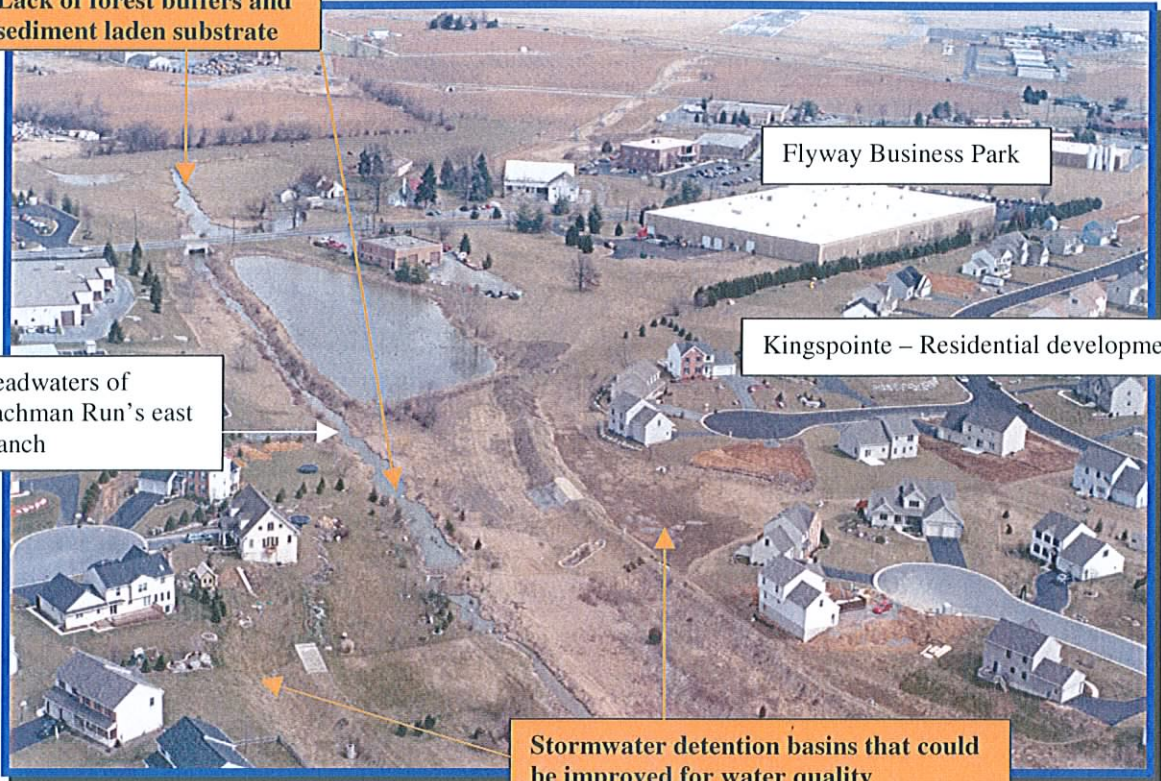
Lack of forest buffers and sediment laden substrate

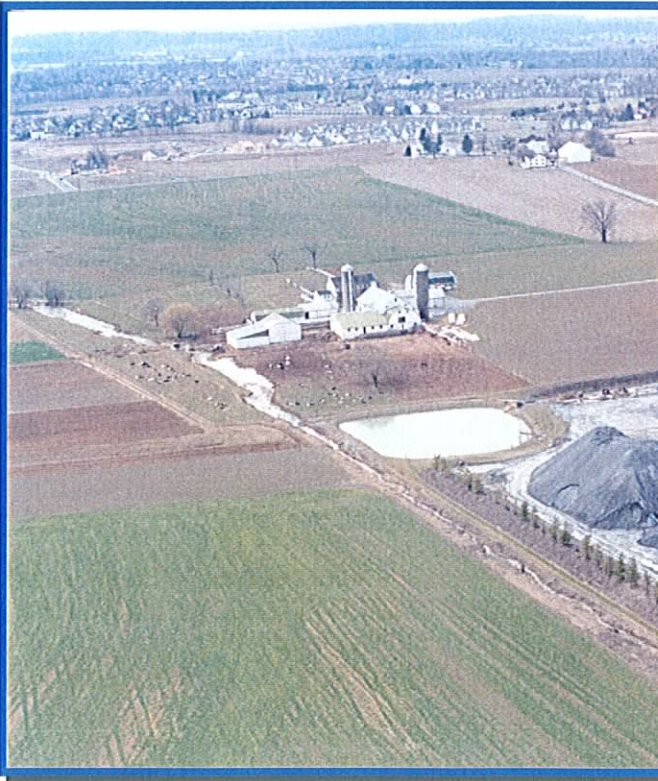
A view of an Amish farm and Rohrer's Quarry at the headwaters of Bachman Run's west branch – The farm is a source of nutrients and sediment mainly through the barnyard area – The quarry is currently in the midst of upgrading their sediment basin and handling of pumped water from the quarry pit to allow for a more consistent flow to the stream rather than periodic surges due to pumps turning on and off

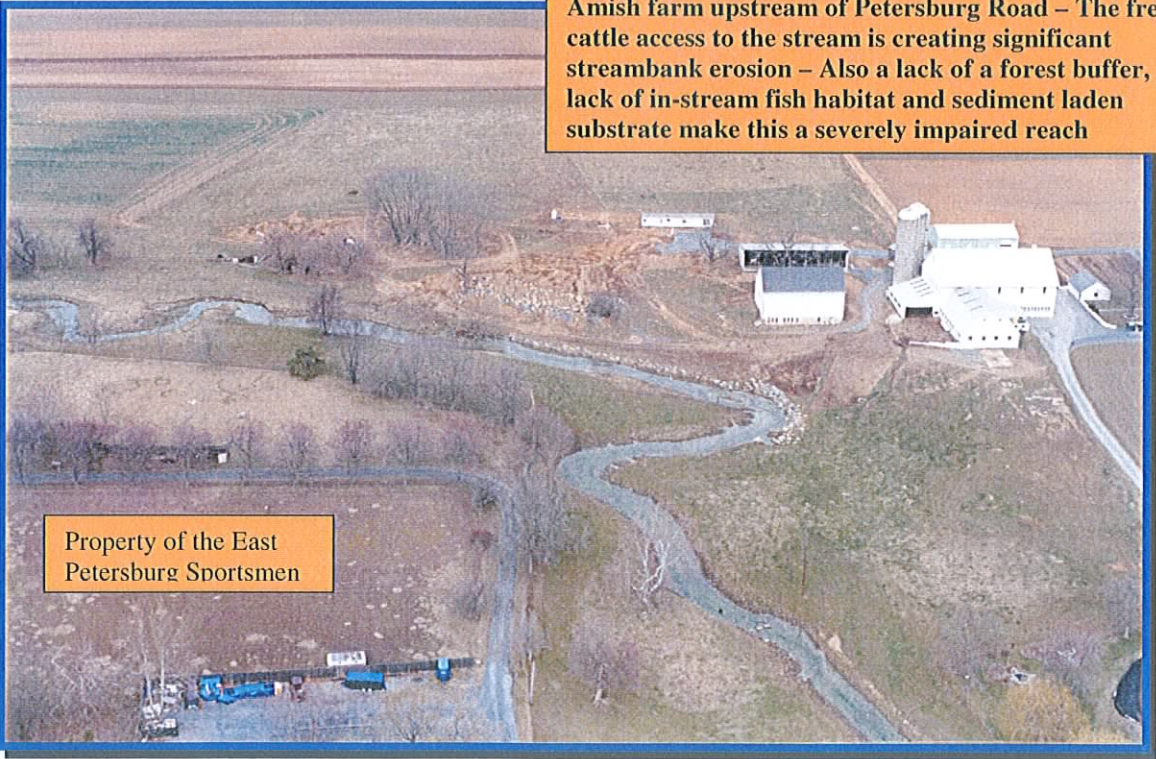
**Amish farm upstream of Petersburg Road – The free cattle access to the stream is creating significant streambank erosion – Also a lack of a forest buffer, lack of in-stream fish habitat and sediment laden substrate make this a severely impaired reach**
